# Performance Evaluation of Concrete Pavement Granular Subbase— Pavement Surface Condition Evaluation

**Final Report**  
**July 2008**

**Sponsored by**  
Iowa Highway Research Board  
IHRB Project TR-554

IHRB Project TR-554  
CTRE Project 06-250

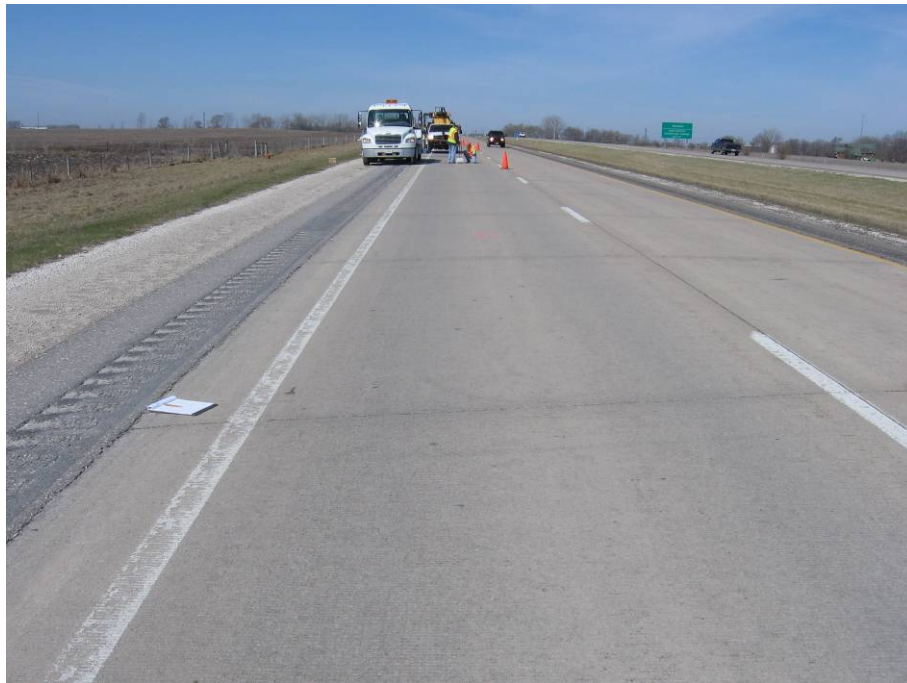
**Figure 21. Picture of US-20 (W) pavement section in Webster County (Mile Post No. 122.50–122.55)—virgin aggregate subbase section**

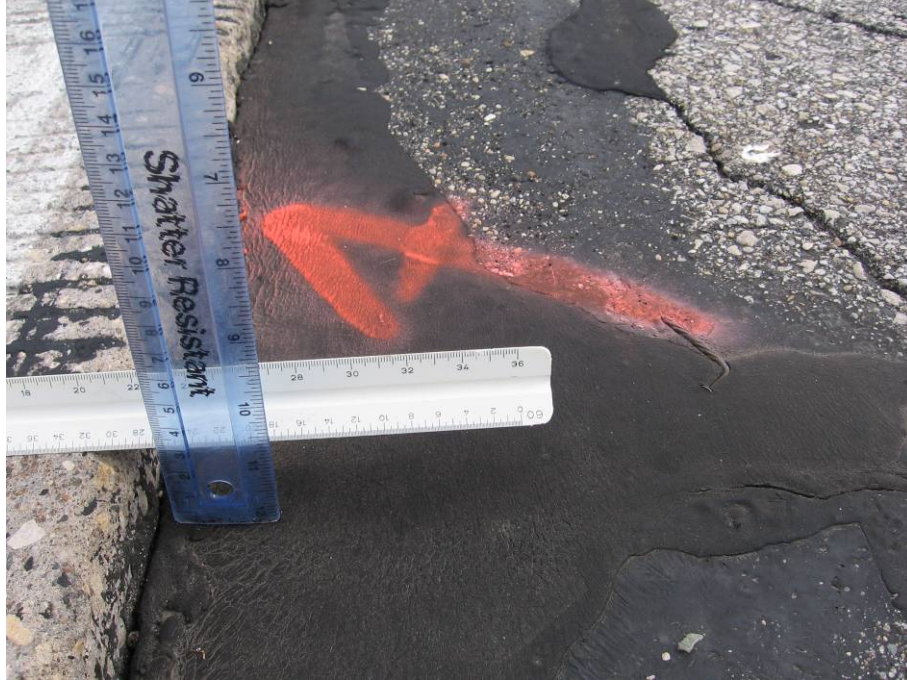
**Figure 24. Lane to shoulder drop off on I-35(N) in Hamilton County (Mile Post No. 131.40–131.45)—RPCC subbase section**

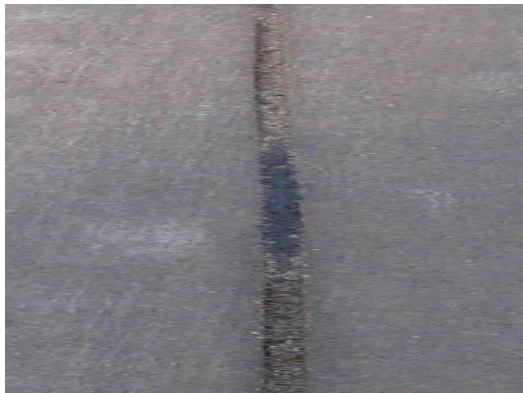
(a) Joint sealing damage of longitudinal joint at slab #1

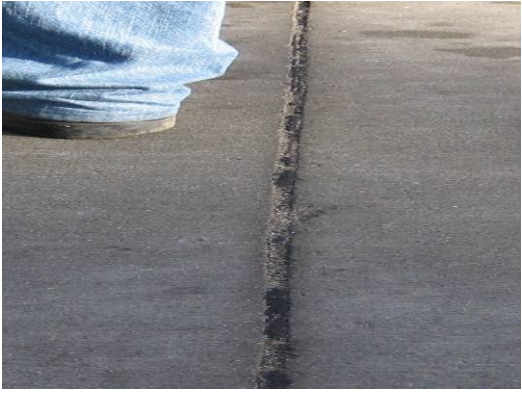
(b) Joint sealing damage of transverse joint at slab #1

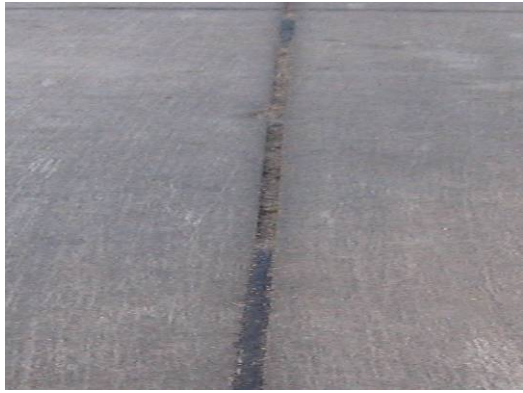
(c) Joint sealing damage of longitudinal joint at slab #2

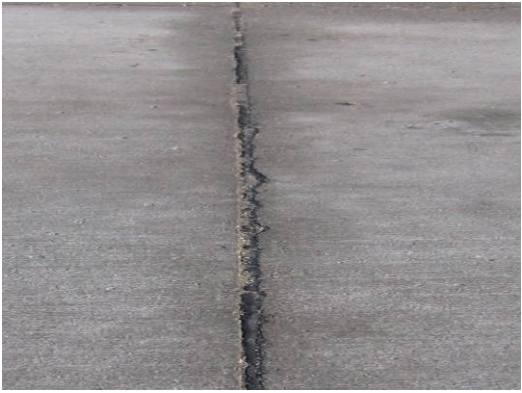
(d) Joint sealing damage of transverse joint at slab #2

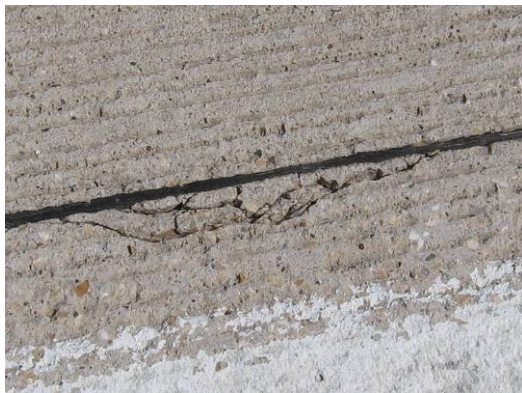
(a) Spalling of longitudinal joint at slab #4

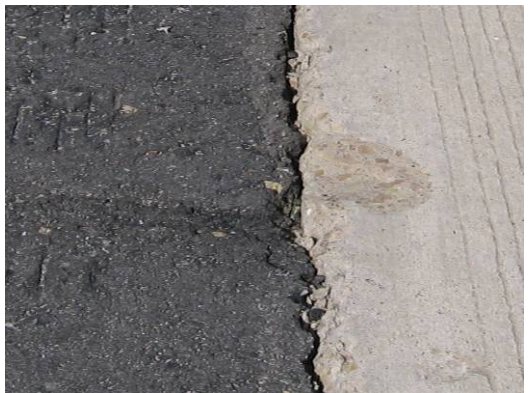
(b) Lane to shoulder separation at slab #5

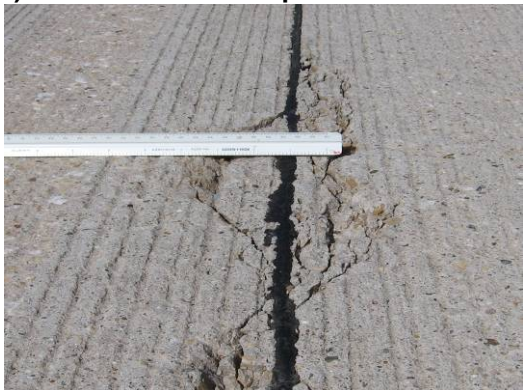
(d) Spalling of longitudinal joint at slab #8

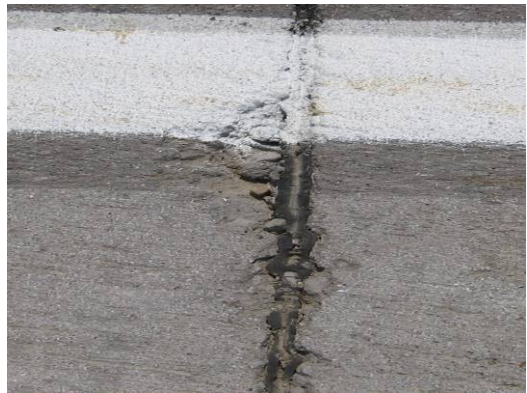
(b) Spalling of transverse joint at slab #12

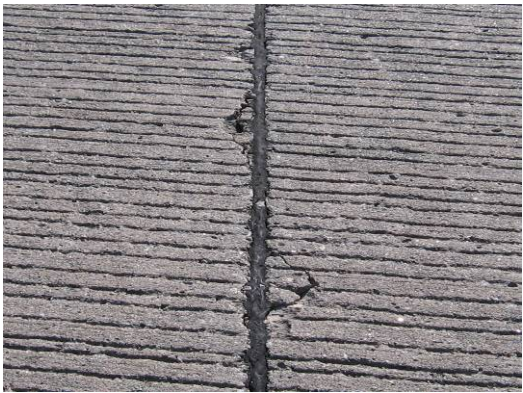
(b) Spalling of transverse joint at slab #5

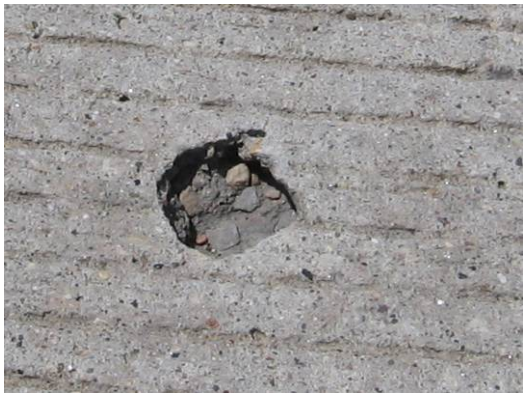
(b) Popout at slab #10

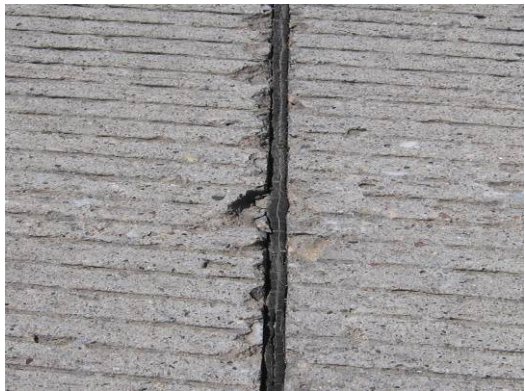
(c) Spalling of transverse joint at slab #14

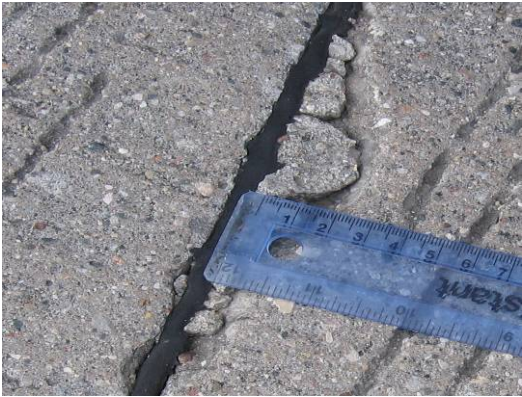
(a) Spalling of transverse joint at slab #4

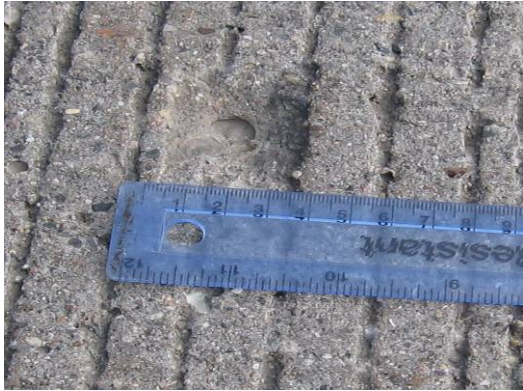
(b) Popout at slab #6

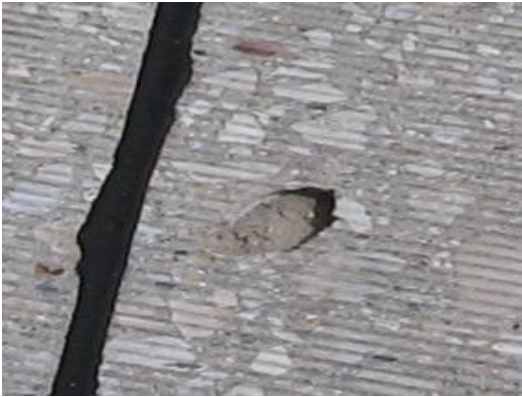
(a) Popout at slab #1

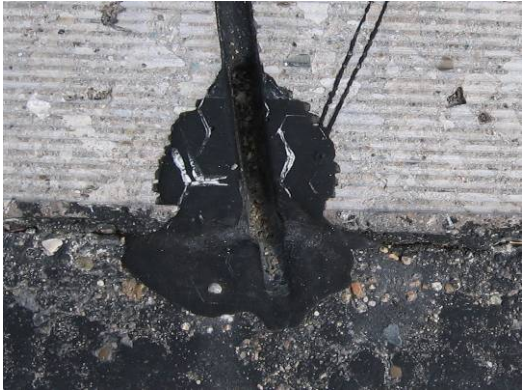
(b) Joint sealing damage of transverse joint at slab #1

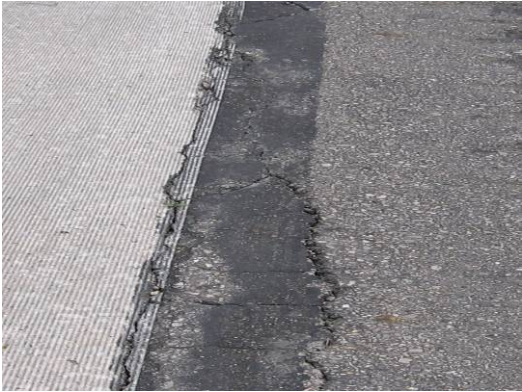
(c) Lane to shoulder separation at slab #15

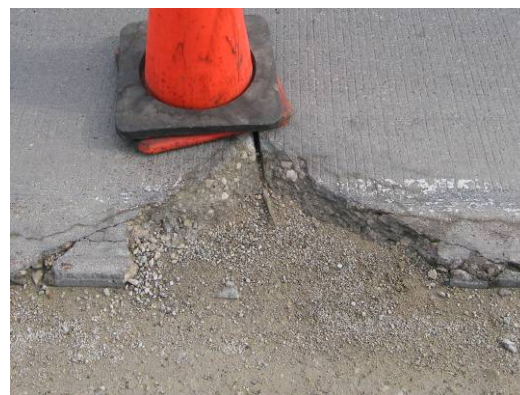
(b) Corner break at slab #12 and #13

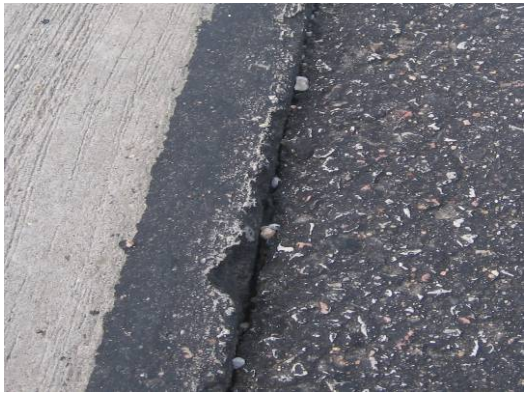
(a) Lane to shoulder separation at slab #2

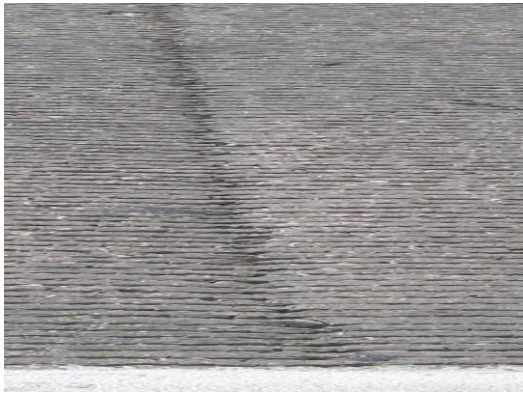
(b) Transverse cracking at slab #5

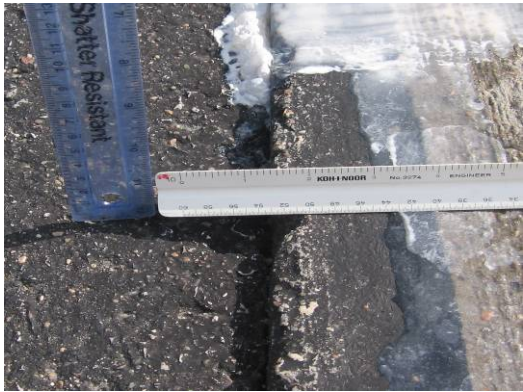
(c) Lane to shoulder drop-off at slab #6

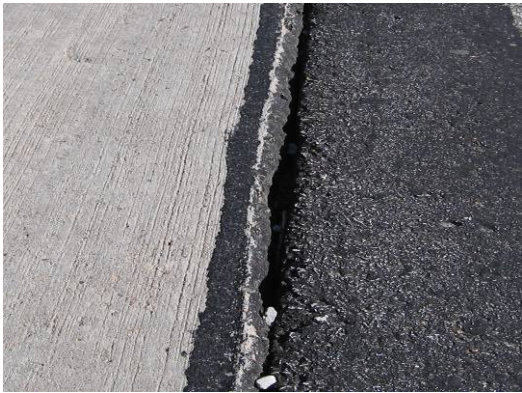
(a) Lane to shoulder separation at slab #1

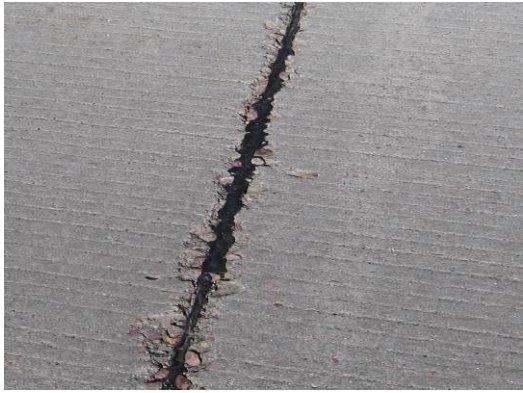
(b) Spalling of transverse joint at slab #5

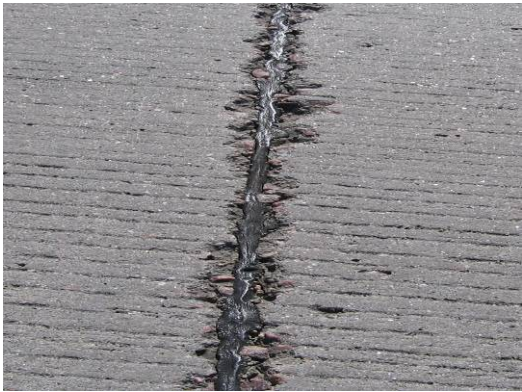
(c) Spalling of transverse joint at slab #7

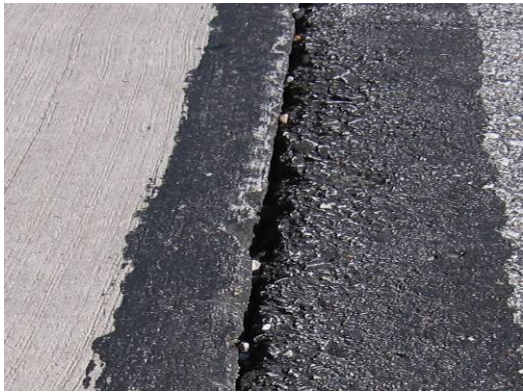
(d) Lane to shoulder separation at slab #10

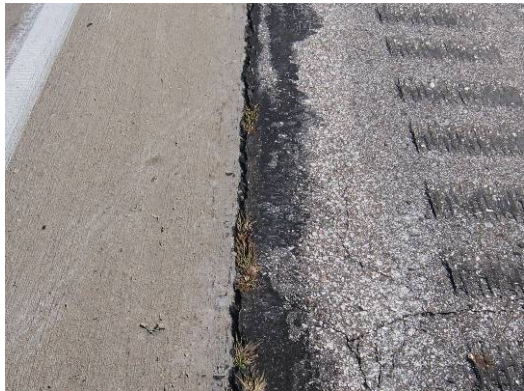
(a) Lane to shoulder separation at slab #2

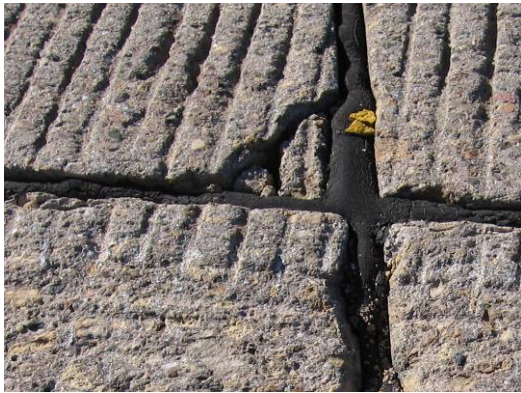
(b) Spalling of transverse joint at slab #5

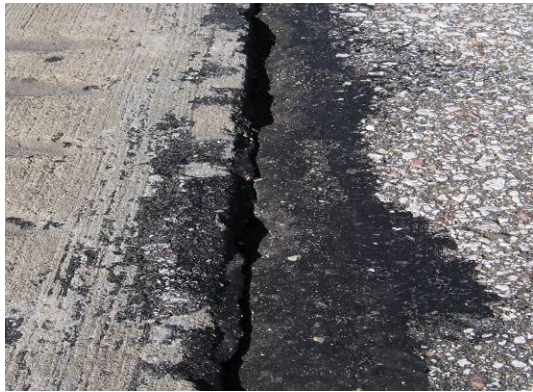
(c) Lane to shoulder separation at slab #15

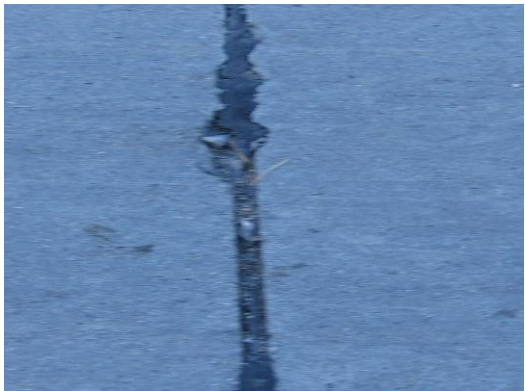
(a) Joint sealing damage of transverse joint at slab #3

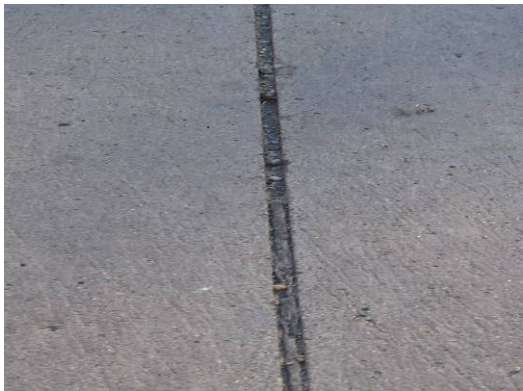
(b) Joint sealing damage of longitudinal joint at slab #6

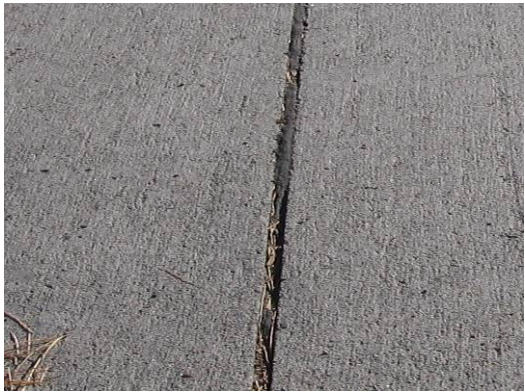
(c) Joint sealing damage of longitudinal joint at slab #8

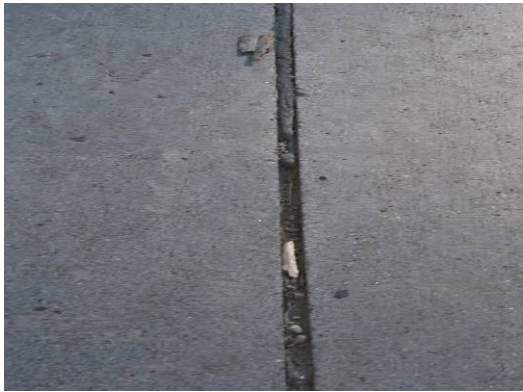
(d) Joint sealing damage of transverse joint at slab #12

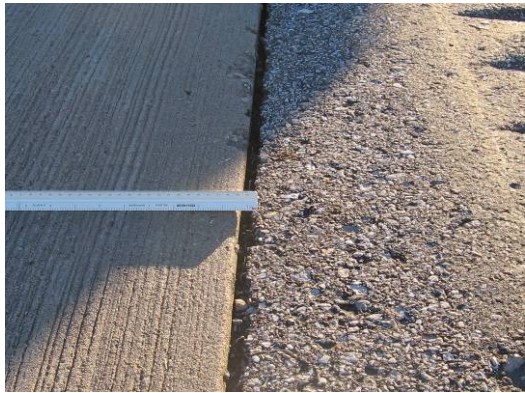
(a) Lane to shoulder separation at slab #3

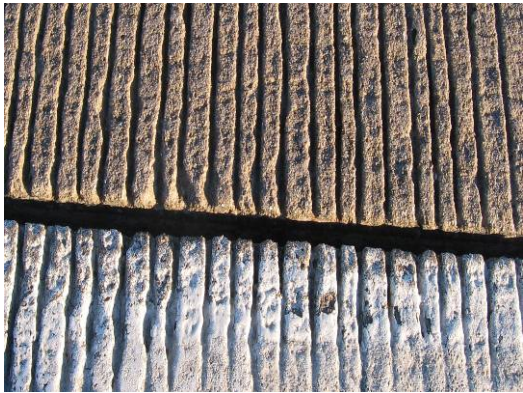
(b) Joint sealing damage of longitudinal joint at slab #4

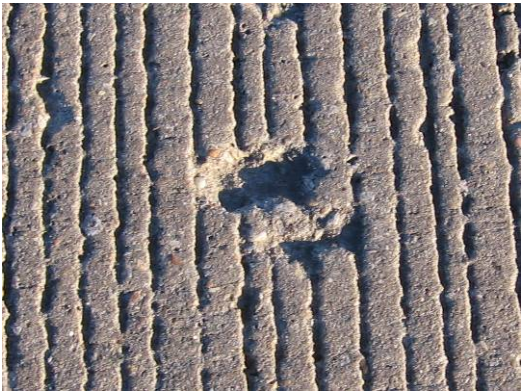
(c) Popout at slab #8

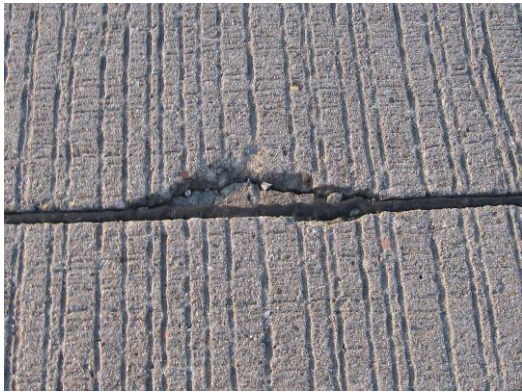
(c) Spalling of longitudinal joint at slab #10

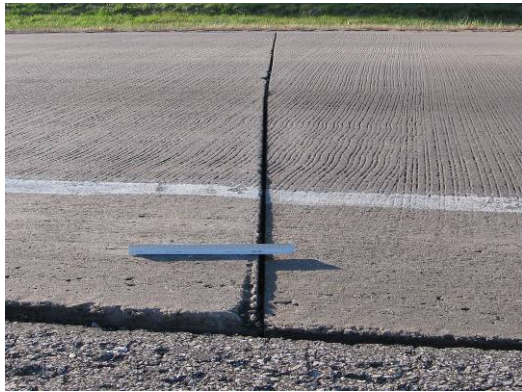
(d) Faulting joint at slab #19

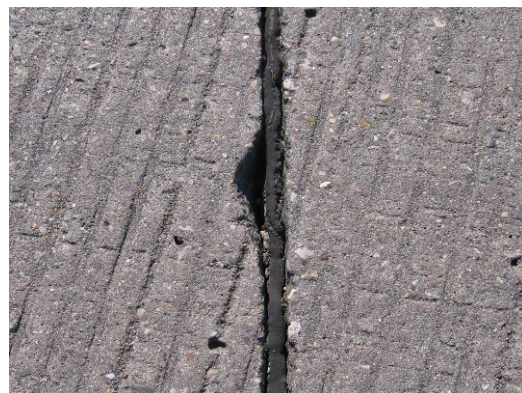
(b) Spalling of transverse joint at slab #12

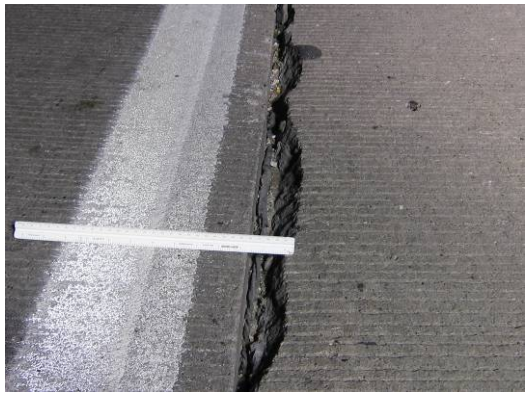
(a) Lane to shoulder separation at slab #1

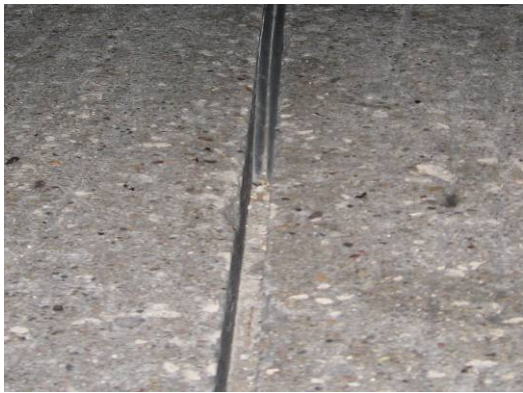
(b) Joint sealing damage of transverse joint at slab #3

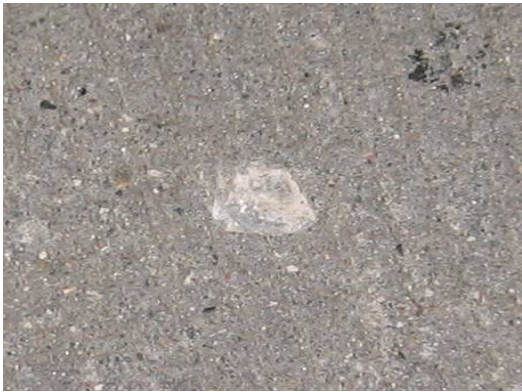
(c) Popout at slab #3

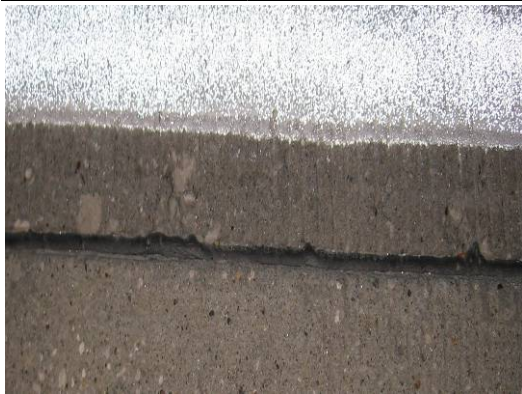
(a) Spalling of longitudinal joint at slab #1

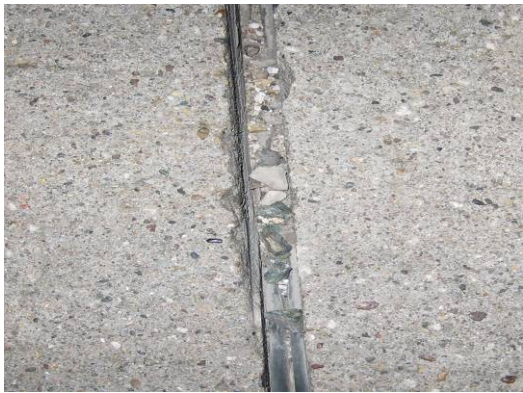
(b) Joint sealing damage of transverse joint at slab #4

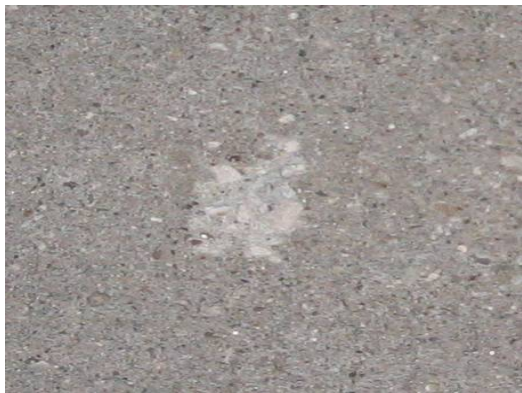
(c) Popout at slab #11

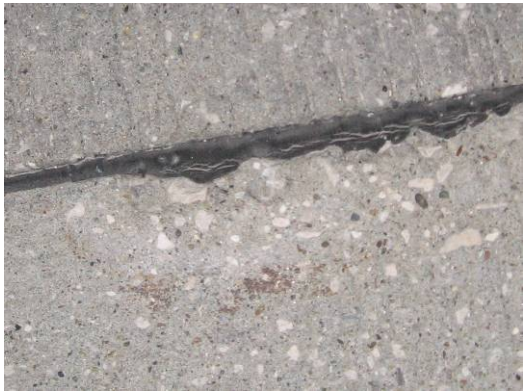
(d) Spalling of transverse joint at slab #15

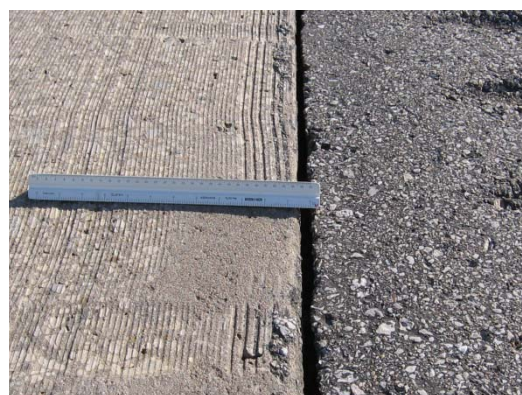
(b) Lane to shoulder separation at slab #9
