Evaluation of Rural Intersection Treatments

Final Report | May 2018

Iowa Highway Research Board
(IHRB Project TR-695)

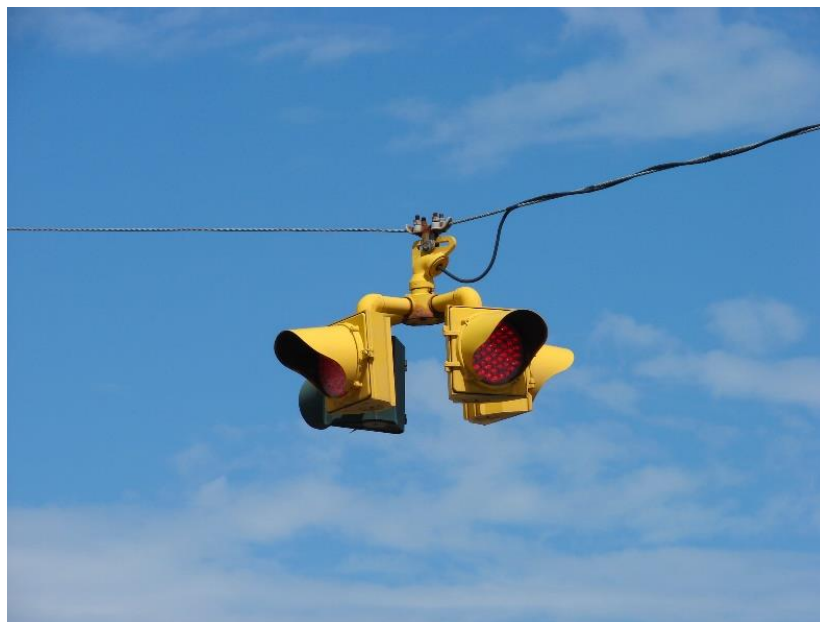
Overhead flashing beacons have been widely used to warn drivers that an upcoming intersection is present. Overhead beacons also remind drivers of who has the right of way (see Figure 1-1). In general, overhead beacons have shown mixed results.

Figure 1-1. Overhead flashing beacon

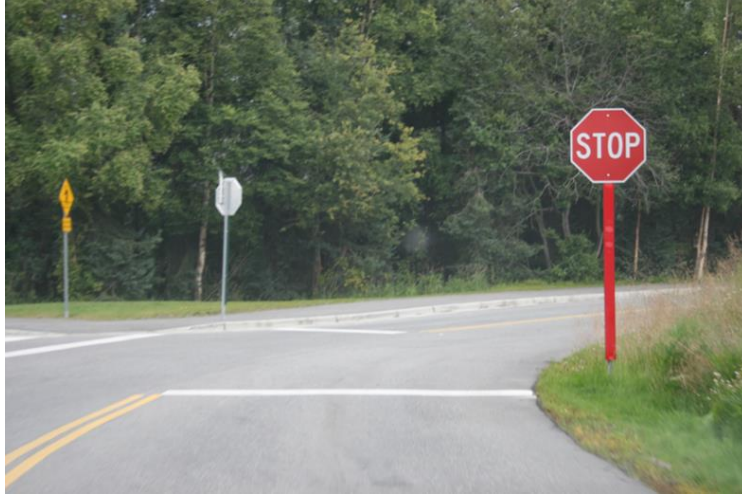
Some agencies have begun adding an additional strip of retroreflective material to stop sign posts to increase their conspicuity (see Figure 1-2).

Figure 1-2. Additional reflective material on stop sign post

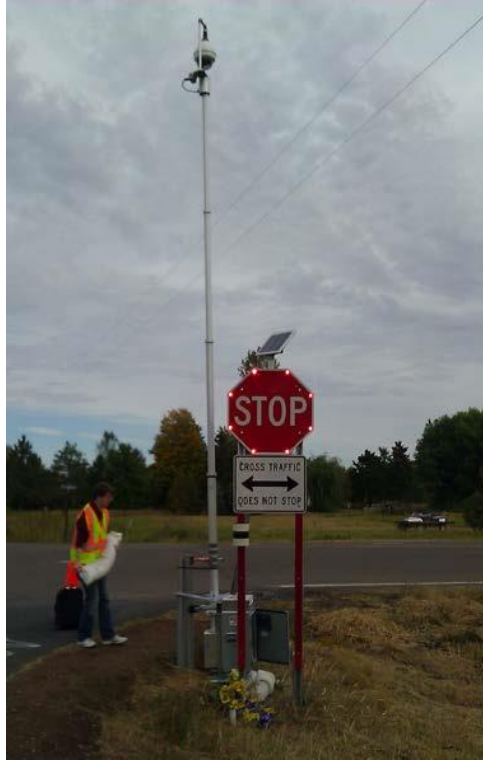
The addition of LEDs embedded in the stop sign face is another strategy that has been used by agencies to increase the conspicuity of the stop sign, as shown in Figure 1-3.

Figure 1-3. Use of LEDs around stop sign face

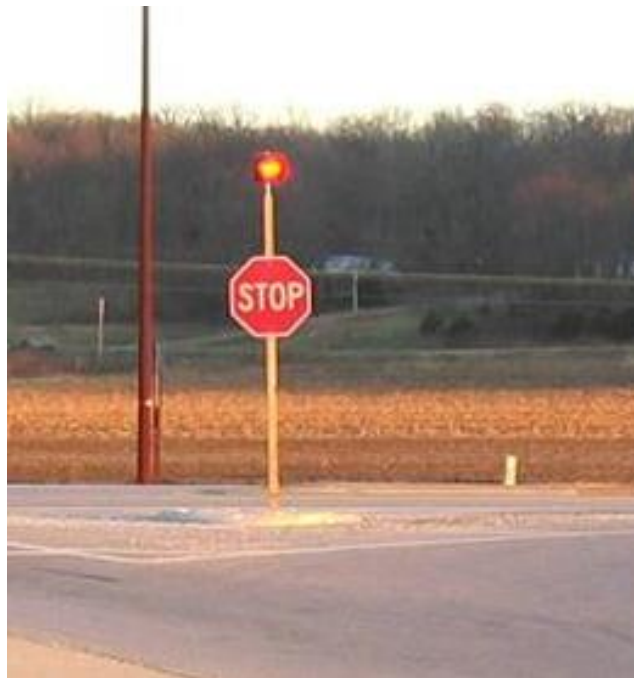
Standard stop sign beacons are usually mounted on a stop sign (Figure 1-4). In some cases, there may also be a warning beacon upstream.

Figure 1-4. Beacon on a stop sign

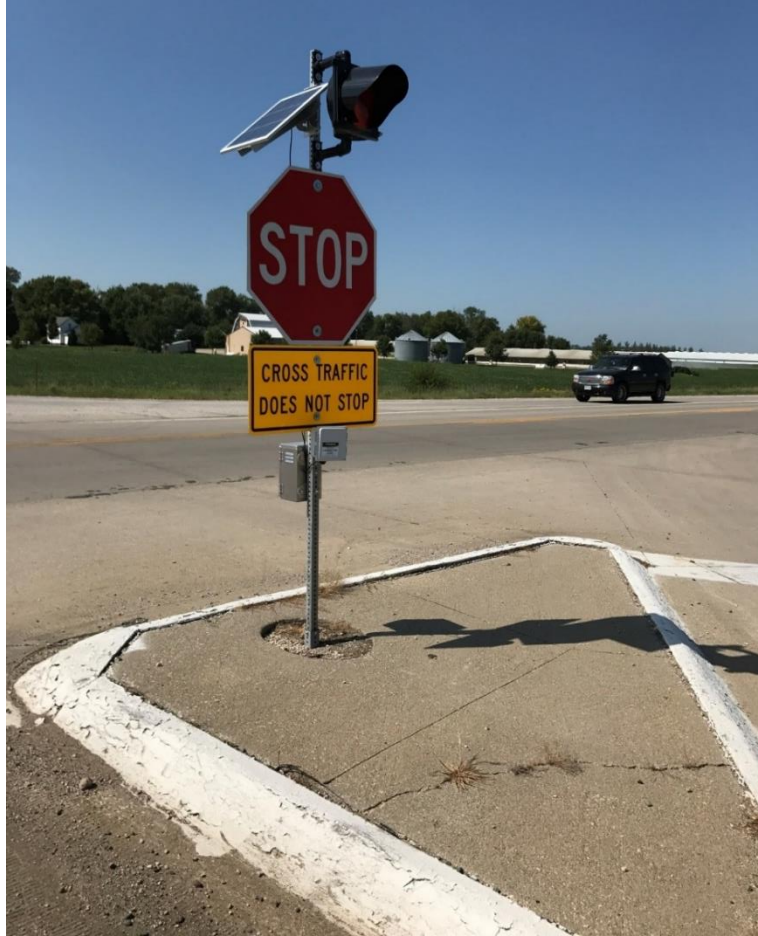
Typically, the sign crew removed the existing telespar pole and replace it with a longer pole to accommodate the beacon, radar, operation box, and solar panel. All items were installed on the same post positioned facing the lane of approaching traffic. An example of a sign installation is shown in Figure 3-1.

Figure 3-1. Flashing beacon installation

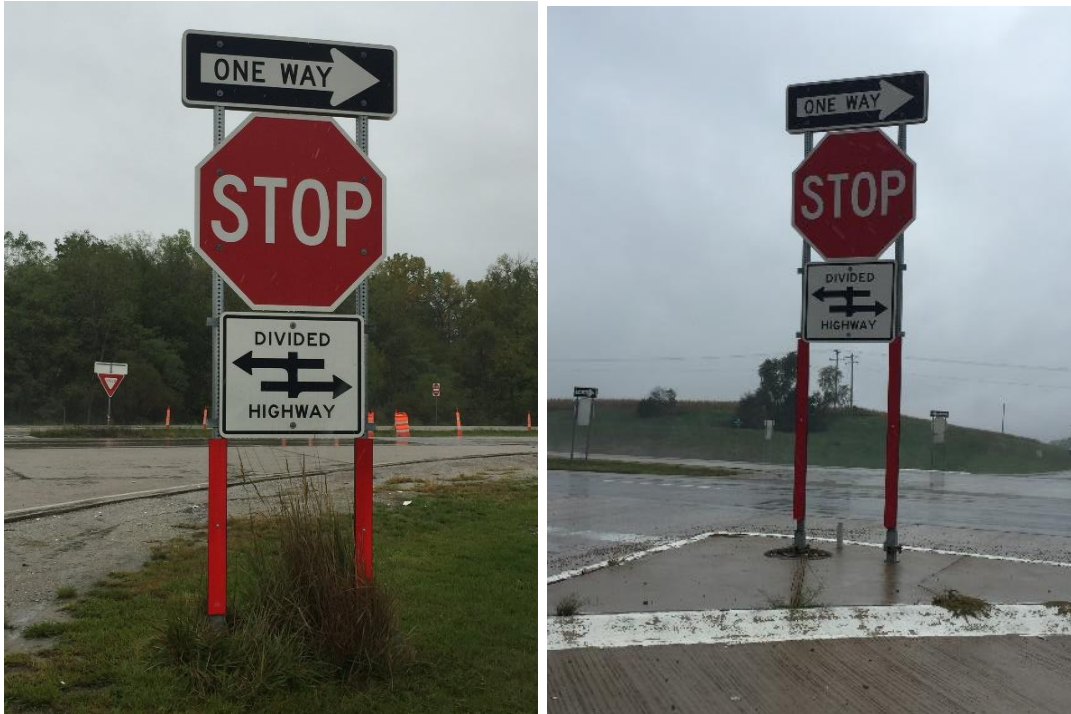
Retroreflective strips were added to the stop sign posts at selected intersection approaches. Sign posts and sign configurations varied. Most of the approaches along two-way/two-way roadways had a single wooden or single telespar post with a stop sign. At the approaches on four-lane divided highways, double telespar posts were present, and additional signs were placed along with the stop sign, as shown in Figure 3-2. This presented challenges because installation techniques had to vary due to differences in post configurations and sign placements.

Figure 3-2. Reflective strip installation at four-lane divided highways

There were additional challenges with installing the strips. In some cases, additional signs were present on the sign post that significantly shortened the distance between the sign and the top of the ground (see Figure 3-2).

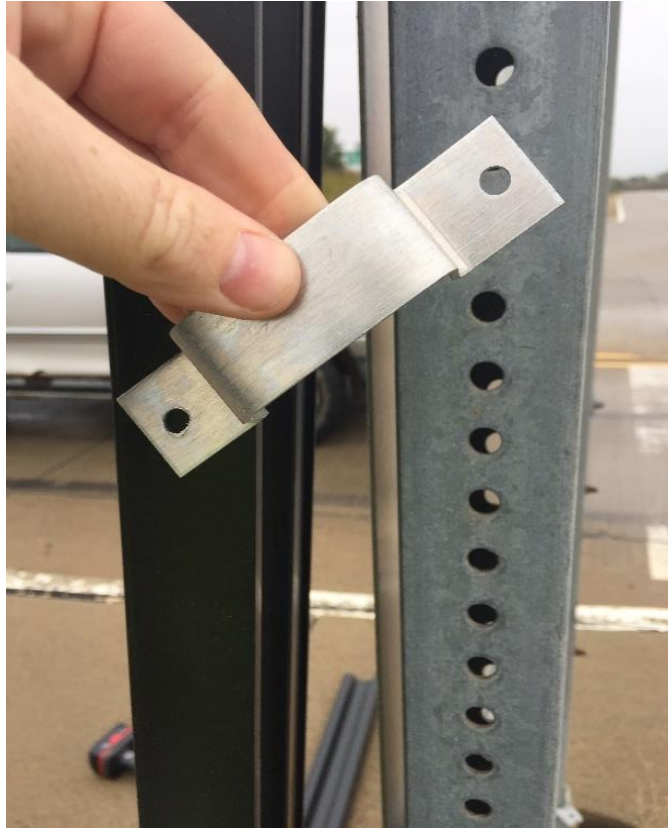
The team also had to adapt due to inconsistencies between the design constraints of the retroreflective strips supplied by the manufacturer and the post sizes at each intersection. For telspar posts, the retroreflective strips were mounted by first drilling holes through the center of the strips and then attaching the strips to the posts with bolts, as shown in Figure 3-3.

Figure 3-3. Retroreflective strip installation on regular telspar posts

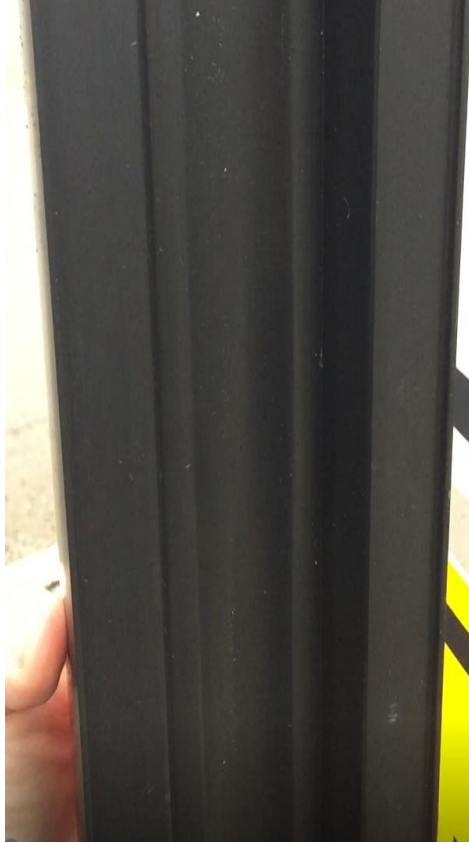
Several telspar posts were smaller than the standard post size. In this case, additional brackets were used, as shown in Figure 3-4.

Figure 3-4. Retroreflective strip placement on smaller telespar post

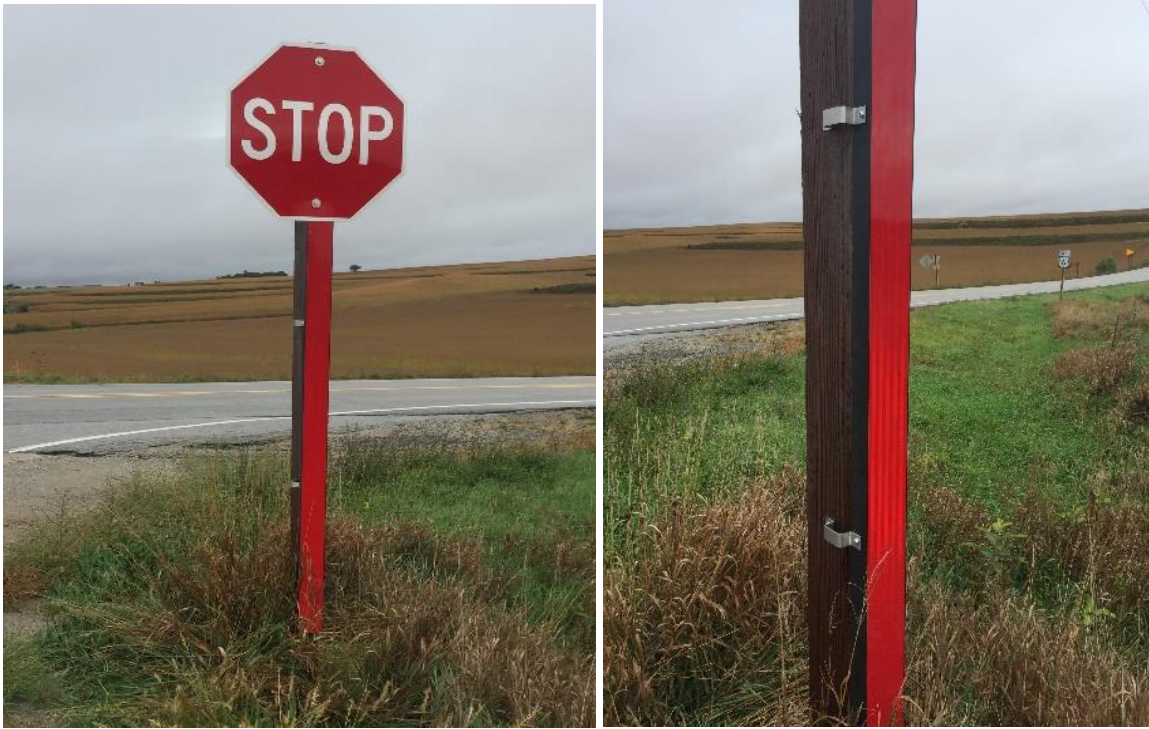
When a single wooden post was present, the manufacturer-supplied brackets were used to install the strips (see Figure 3-5).

Figure 3-5. Retroreflective strip installation on wooden post

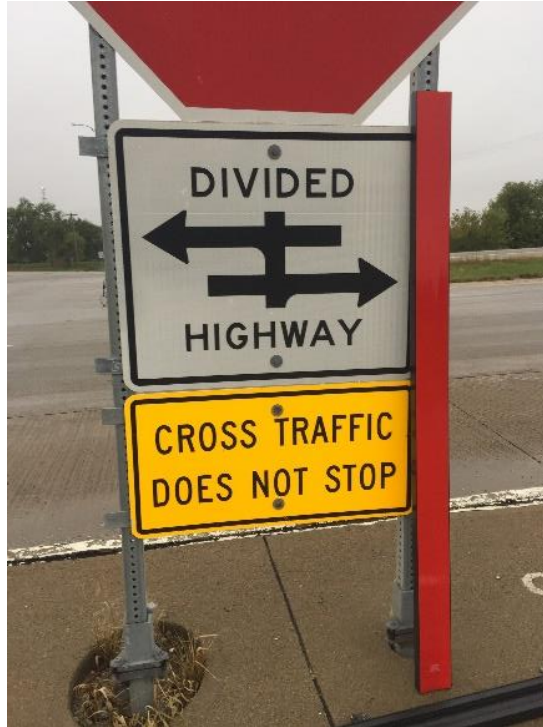
In several cases, the strip could still be installed but was shortened to accommodate the additional signs. In at least one case, an attempt was made to affix the strip over the bottom existing signs, but ultimately it was determined that the countermeasure would not stay in place and the strip was removed (see Figure 3-6).

Figure 3-6. Installation not possible due to sign and spacing constraints

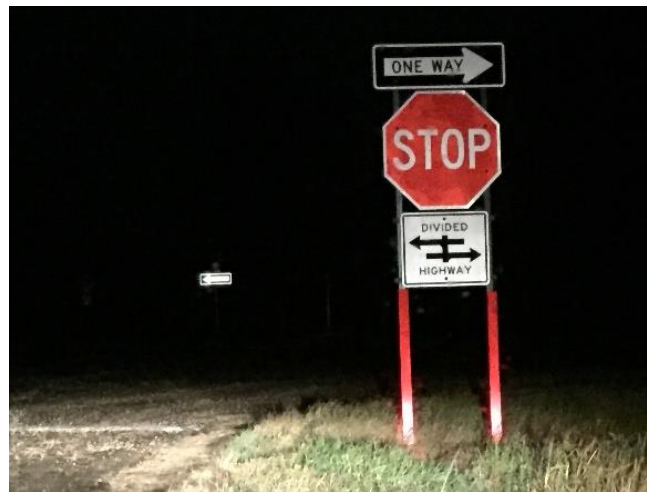
An view of the retroreflective countermeasure at night is shown in Figure 3-7.

Figure 3-7. Nighttime view of retroreflective strip

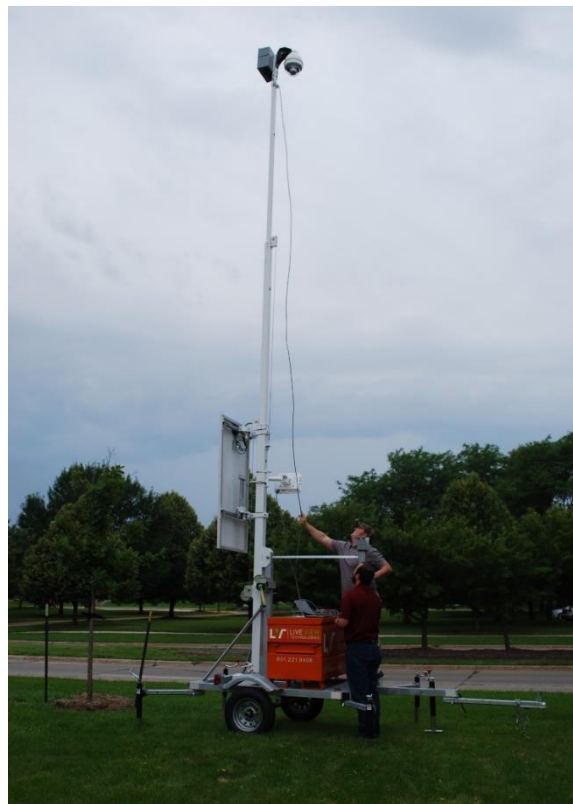
Portable data collection trailers with speed sensors and cameras were used for the data collection. A trailer array was set up at each approach where beacons were installed, as shown in Figure 4-1. This ensured coverage of some portion of the upstream approach as well as the intersection.

Figure 4-1. Video data collection array

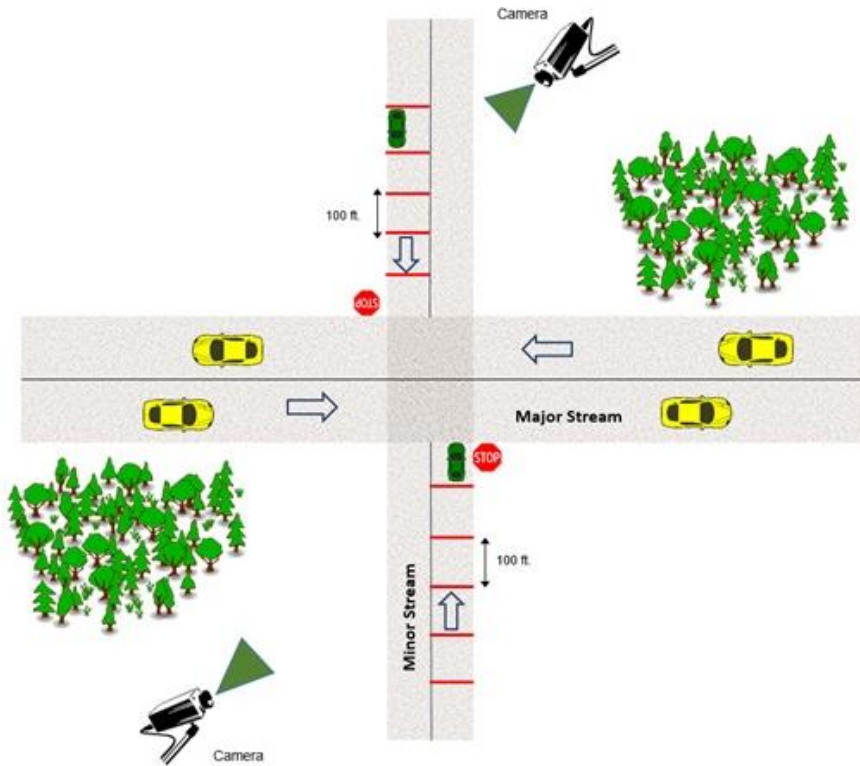
Figure 4-2 illustrates a schematic of the data collection setup.

Figure 4-2. Video data collection setup

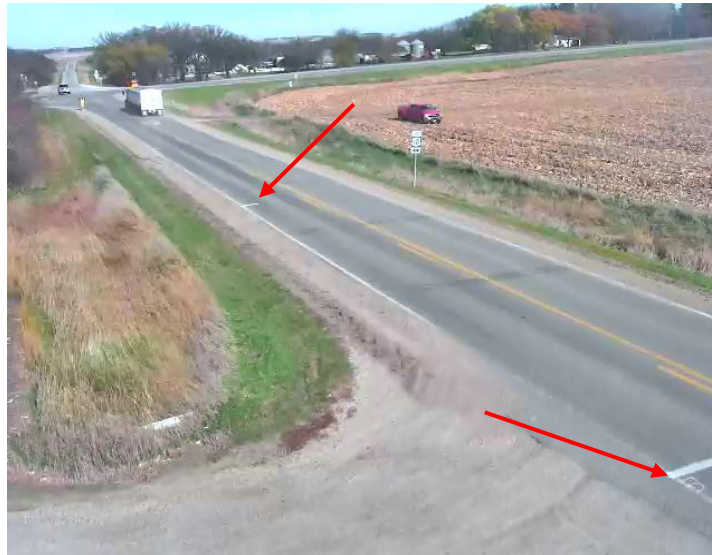
To accurately record the distance from each vehicle to the flashing beacon, white lines were painted on the pavement at 100 ft increments upstream of the intersection, as shown in Figure 4-3.

Figure 4-3. White lines marked in the field

These markings were placed for a distance of 500 ft upstream of the intersection stop bar. These markings were used as a reference in the video to approximate the point at which drivers began applying their brakes. The lines were then located in the video frame and marked (see Figure 4-4) so that they were clearly visible to the data reductionists.

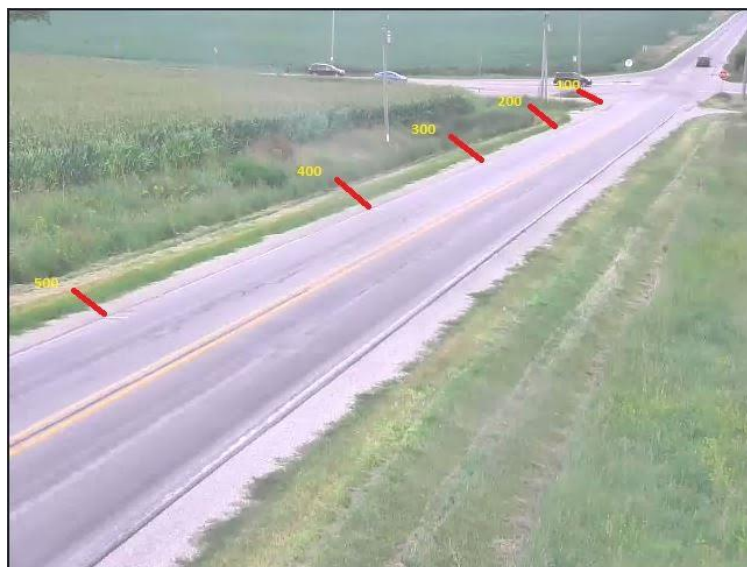
Figure 4-4. Marks placed in video frame to ensure distances are visible to data reductionists

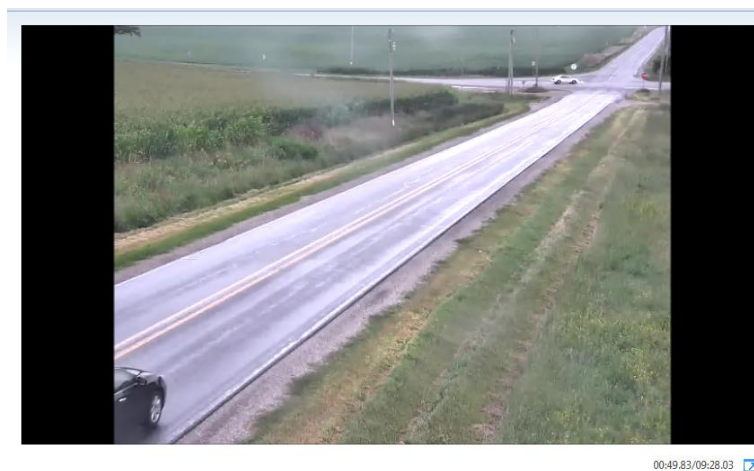
A time stamp was recorded for the first time a vehicle appears in the video (see Figure 4-5). The time stamp was noted as soon as the front of the vehicle was visible in the video. This was reduced so that the vehicle could be easily found later if needed.

Figure 4-5. First appearance of vehicle in video frame

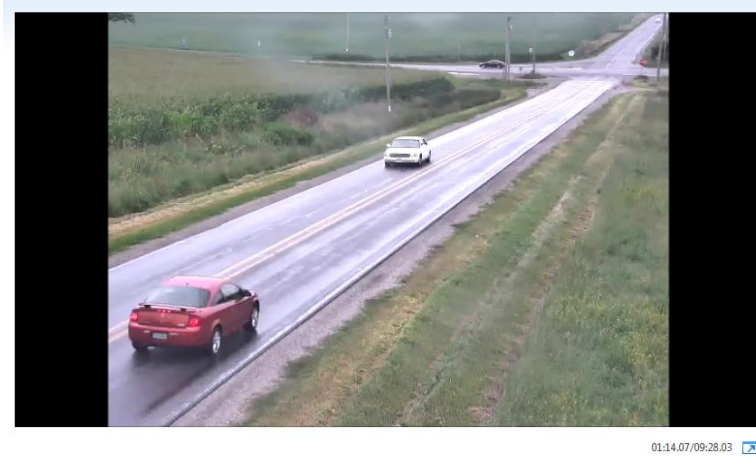
The time when a driver first applied the brake to decelerate a vehicle was noted as “brake activation time.” This was determined by noting the activation of the brake lights for the vehicle. An example of brake activation is shown in Figure 4-6.

Figure 4-6. Brake activation

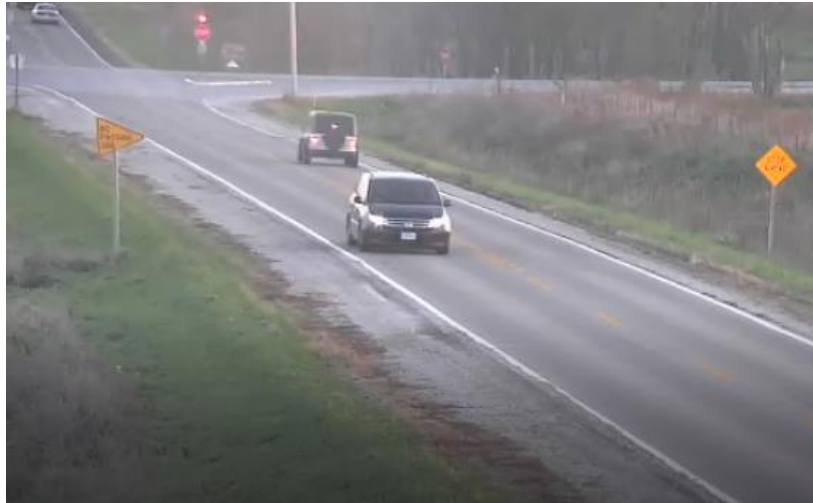
active.” When activated, it was assumed that the subject vehicle (or surrounding vehicles) was traveling over 40 mph at the trigger point 350 ft upstream. If the beacon was active at any point while the subject vehicle was present within the video frame (Figure 4-7), beacon status was marked as “active.” If the beacon was activated at some point after the vehicle entered the frame, status was also marked as active.

Figure 4-7. Activated beacon in Dallas County

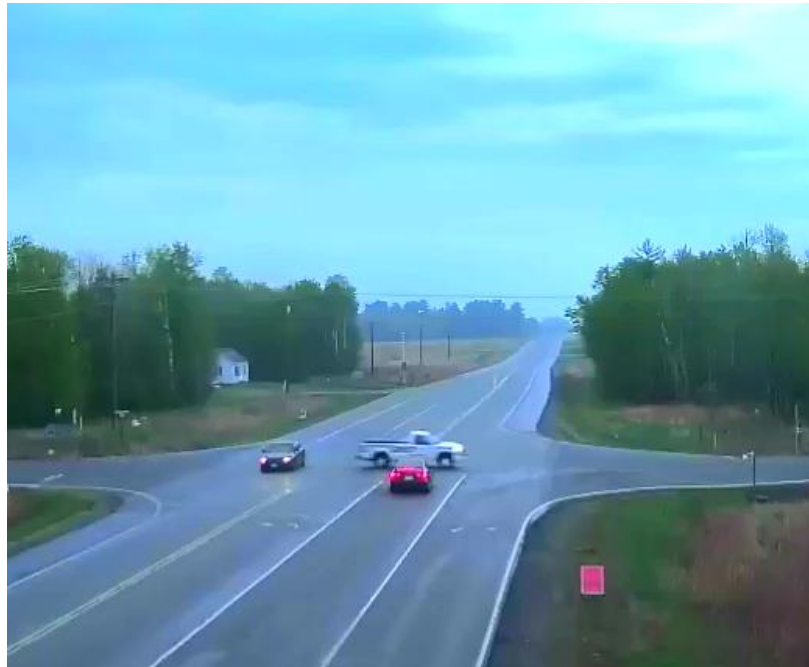
Unlike other metrics, where a subset of vehicles was sampled, all video data were reviewed to identify conflicts. As a result, all evasive maneuvers that occurred during the daytime data collection period were recorded. Figure 4-8 shows an example of an evasive maneuver.

Figure 4-8. Example of conflict

No crashes were observed at any of the locations when data collection was in progress. Additionally, very few conflicts were recorded during any of the analysis periods. As a result, conflicts were not further evaluated as a measure of effectiveness.

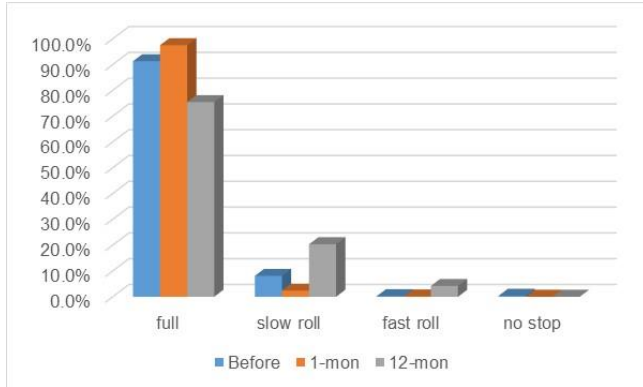
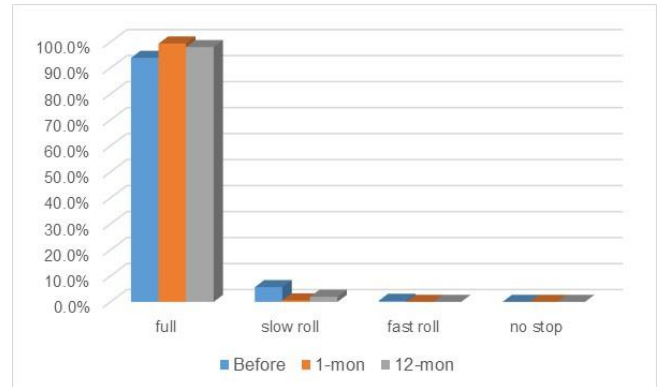
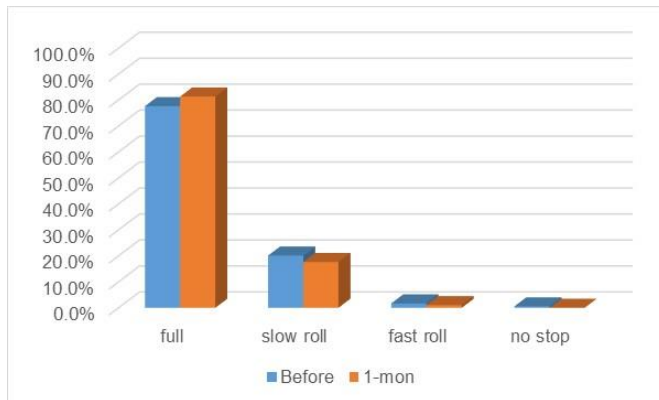
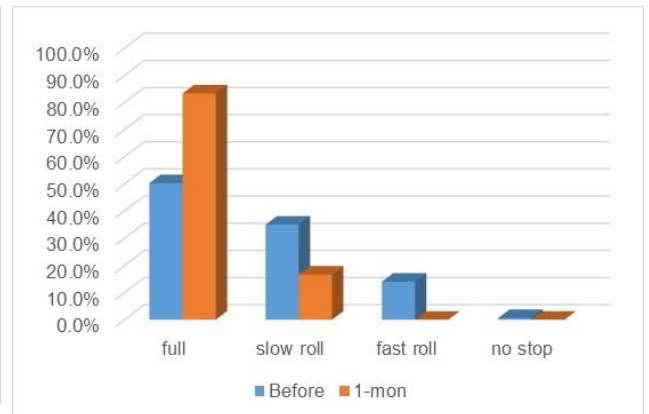
In this section, results are presented by individual intersection approach for the before, 1-month after, and 12-month after periods. Changes in type of stop for the north and south approaches of the intersection of Lincoln Highway and 21st Ave (Benton County) are shown in Figure 5-1.

Figure 5-1. Changes in type of stop (Benton and Buena Vista Counties)

Changes in type of stop for the intersection of 130th Ave and 590th Street in Buena Vista County are also shown in Figure 5-1. The percentage of vehicles coming to a full stop increased by 3.7% at the east approach and 33.0% at the west approach at 1 month after installation. The percentage of vehicles that did not come to a stop decreased from 0.6% to 0% at both the east and west approaches. Data were not available for either approach at 12 months after installation.

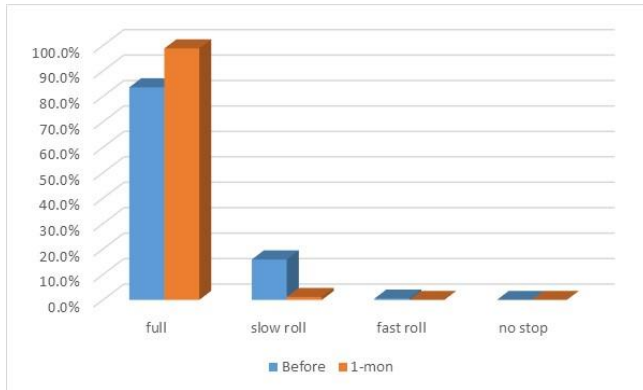
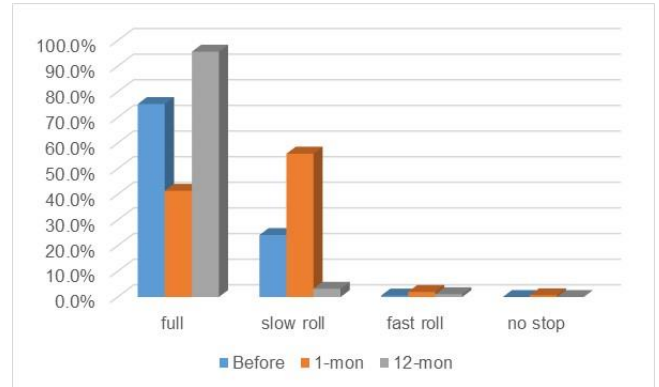
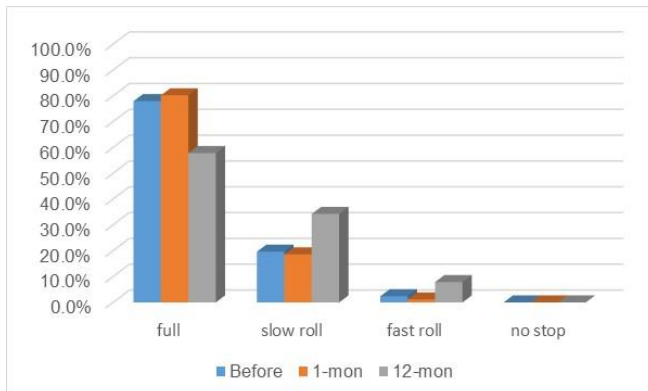
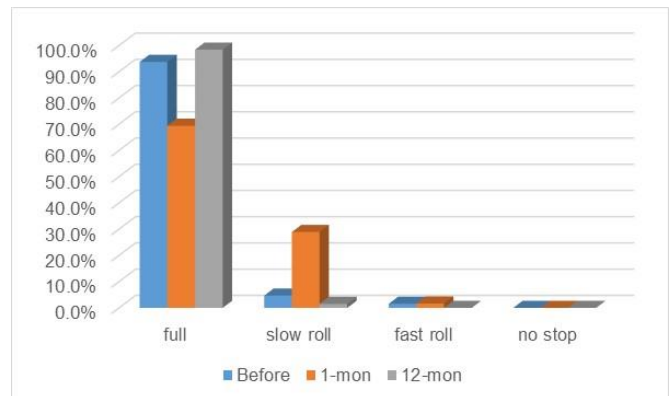
Results for the Clay and Dallas County approaches are shown in Figure 5-2.

Figure 5-2. Changes in type of stop (Clay and Dallas Counties)

Neither of the Dallas County approaches experienced non-stops in the before period, and no change was observed for the 1-month or 12-month after periods.

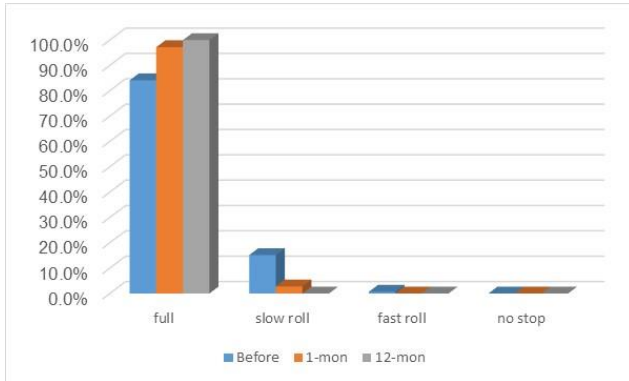
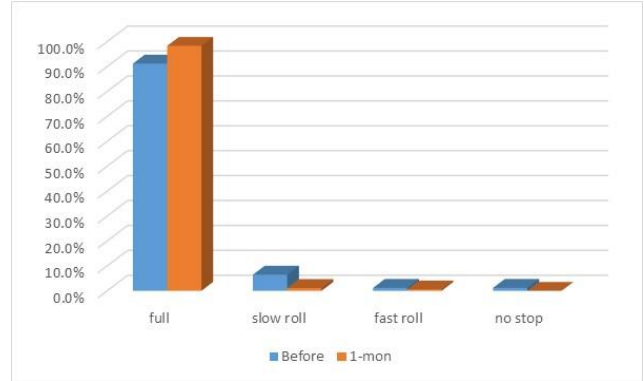
Changes in type of stop for the west approach of the intersection of Hwy 1 and 140th St NE (Johnson County) and the west approach of the intersection of US 75 and 8th St SW (Sioux County) are shown in Figure 5-3.

Figure 5-3. Changes in type of stop (Johnson and Sioux Counties)

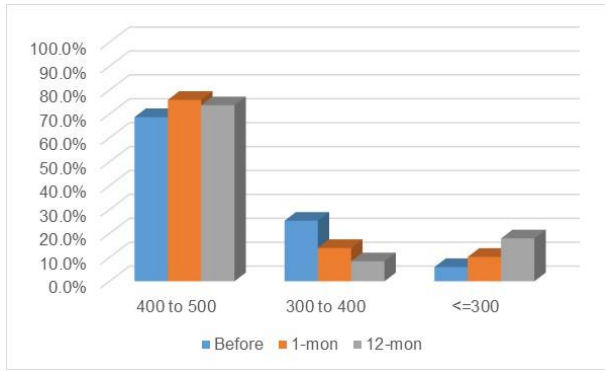
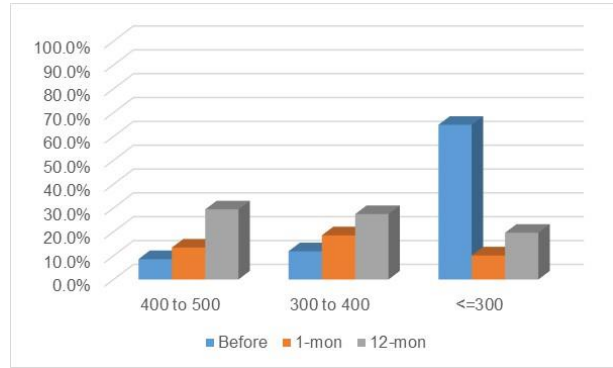
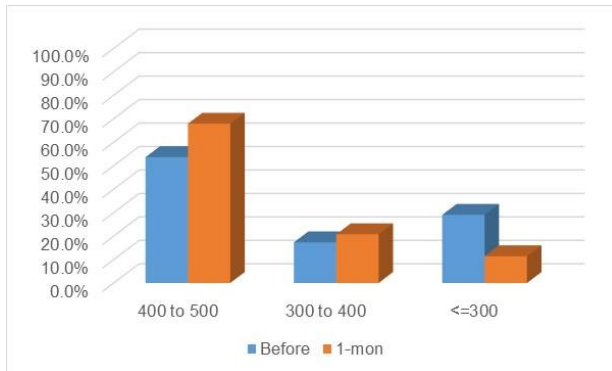
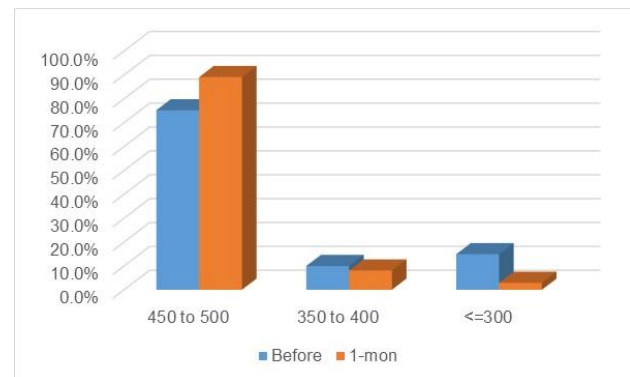
The point at which drivers initially began to brake was recorded, and results are provided in this section. Figures 5-4 to 5-6 show results by individual approaches, and information is provided as the percentage of vehicles that began braking within a specified distance.

Figure 5-4. Changes in initial braking point (Benton and Buena Vista Counties)

As noted in Chapter 4, the point of initial braking was the point at which drivers first applied their brakes. Distance was measured in 50 ft intervals from the intersection approach bar. In order to provide more a meaningful discussion, distance was aggregated into the following bins:

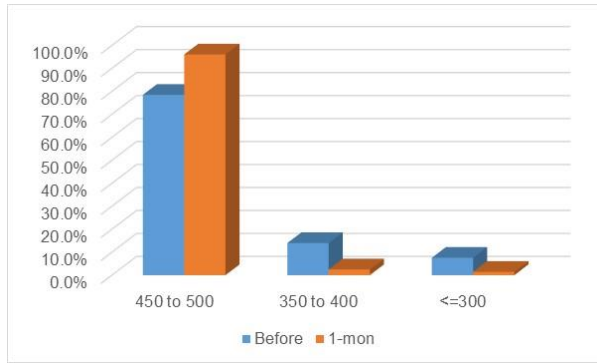
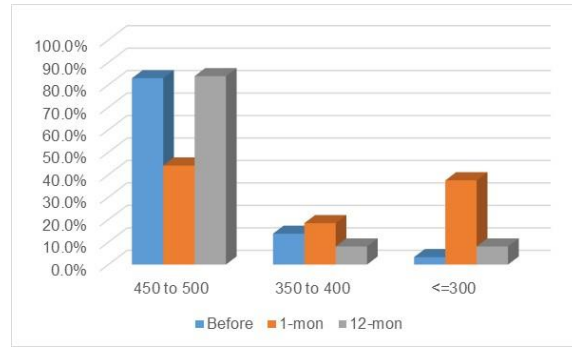
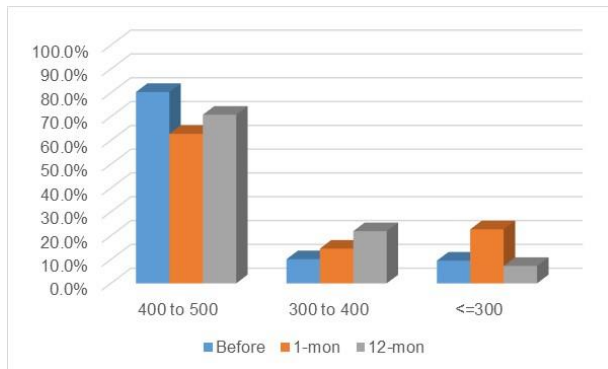
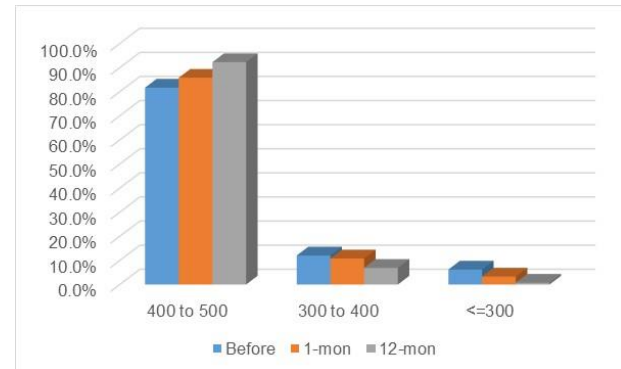
Figure 5-5. Changes in initial braking point (Clay and Dallas Counties)

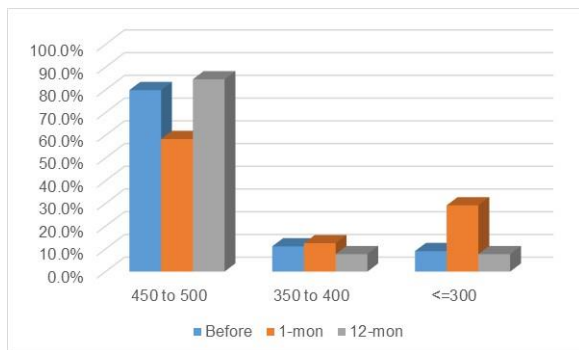
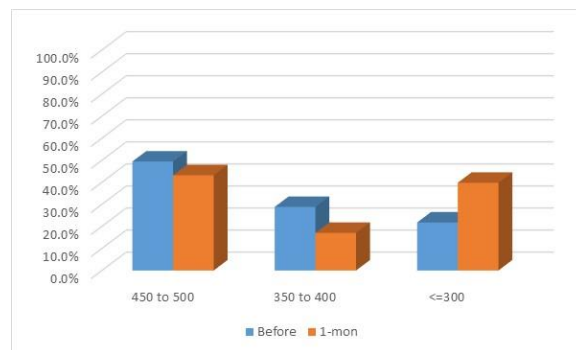
Figure 5-6. Changes in type of stop (Johnson and Sioux Counties)
