# Improving the Foundation Layers for Concrete Pavements

## Pavement Foundation Layer Reconstruction – Iowa US 30 Field Study

**March 2016**

# **IMPROVING THE FOUNDATION LAYERS FOR CONCRETE PAVEMENTS: PAVEMENT FOUNDATION LAYER RECONSTRUCTION – IOWA US 30 FIELD STUDY**

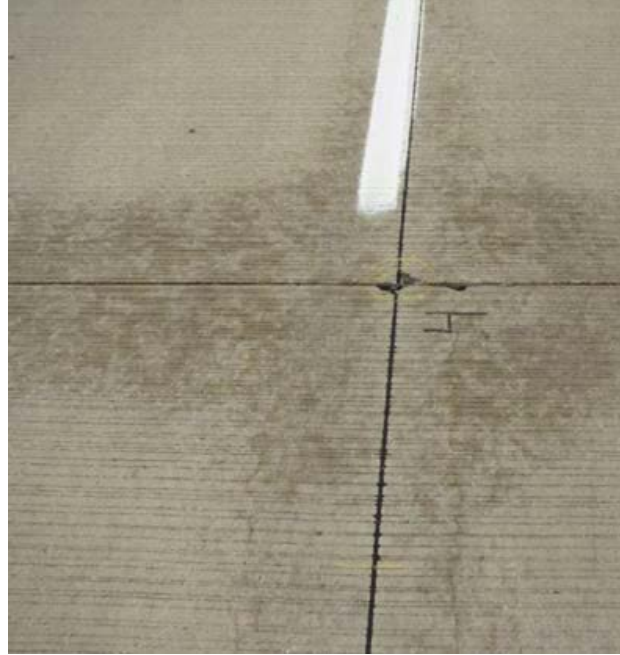
**Figure 1. Typical shadowing with trapped water and micro-cracks (Taylor 2011)**

Water trapped near joints contributes to freezing-related deterioration. Two main factors result in trapped water near joints, the lack of proper sealing (or a failed seal) near joints and poor drainage of underlying base layers. Pavements that are subjected to longer saturation periods, concretes with marginal air void systems, and high usage of de-icing salts contribute to freezing-related deteriorations. These type of deteriorations progress rapidly once the damage starts (Taylor 2011). Zhang et al. (2015) reported that in jointed portland cement concrete (JPCC) pavements, low permeability in base layers beneath the pavements correlates with joint deterioration.

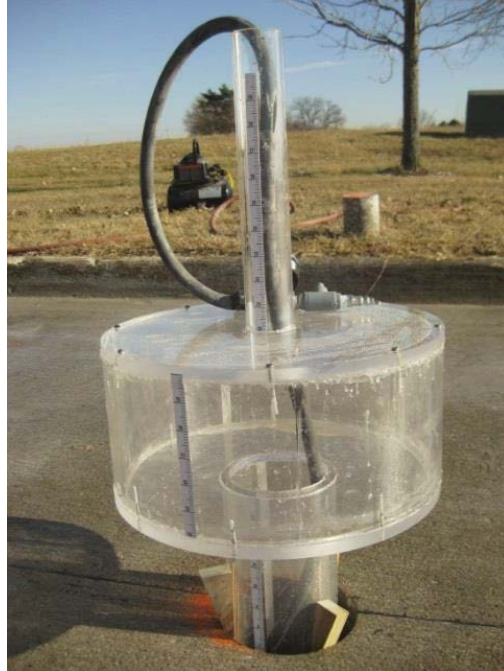
**Figure 2. Borehole permeameter setup developed by Iowa State University (Zhang et al. 2013)**

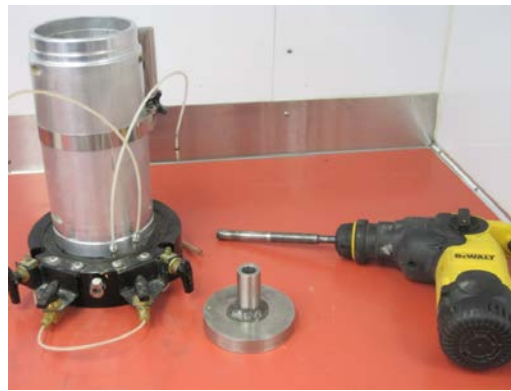
**Figure 17. Split mold, steel platen (4 in. diameter), and vibratory hammer for compaction of subbase material samples**

Samples for  $M_r$  tests and repeated load cyclic triaxial testing were prepared according to AASHTO T307-99. Homogeneous samples of subbase materials were tested for resilient modulus ( $M_r$ ) and unconsolidated undrained (UU) shear strength generally following the AASHTO T-307 procedure—granular base/subbase Type I material. Samples were prepared using the vibratory compaction method as described in AASHTO T-307. Prior to compaction, materials were moisture-conditioned and allowed to mellow for at least 3 to 6 hours. A 101.6 mm (4 in.) diameter split mold was used to compact the sample (Figure 17) in five lifts of equal mass and thickness using an electric rotary hammer drill and a circular steel platen placed against the material (Figure 18). Calipers were used to verify consistent compaction layer thicknesses (Figure 18).

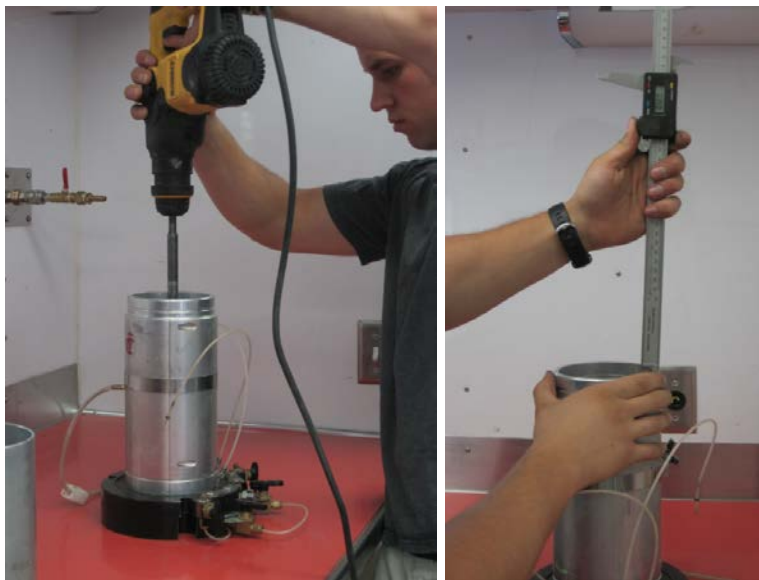
**Figure 18. Compaction of subbase material samples in the split mold (left) and verification of thickness of each lift using calipers (right)**

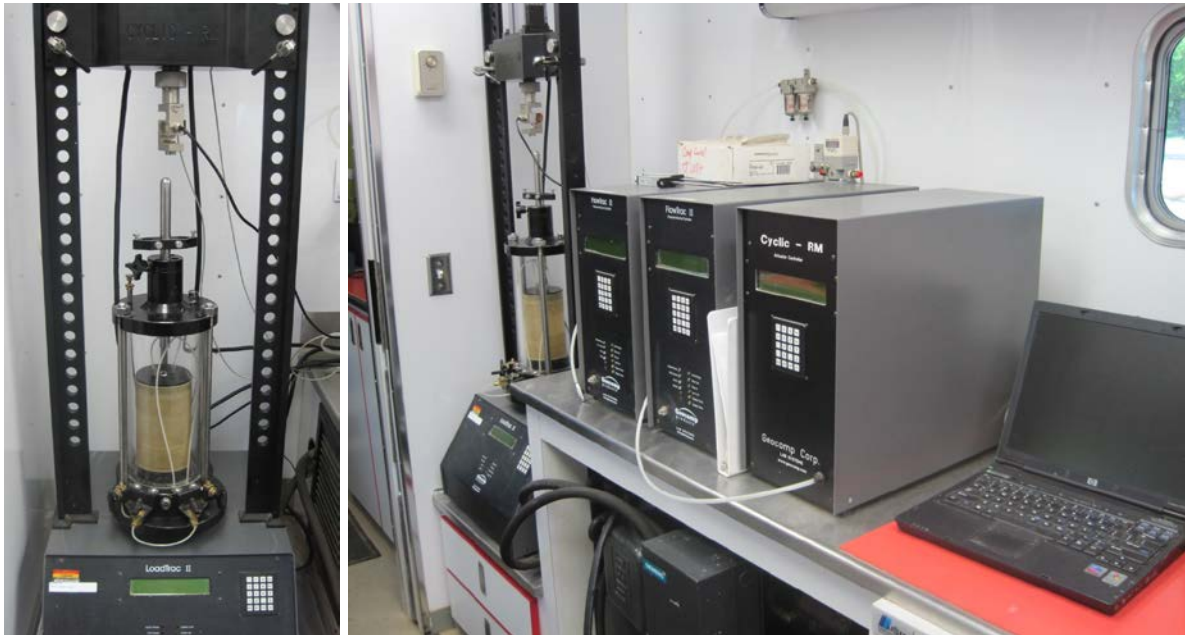
**Figure 19. Triaxial chamber (left) and triaxial chamber, load frame, and computer equipment for resilient modulus tests (right)**

$M_r$  tests were performed following the AASHTO T-307 conditioning and loading sequences suggested for base and subgrade materials (Table 3). Each load cycle consisted of a 0.1 second haversine-shaped load pulse followed by a 0.9 second rest period.  $M_r$  is calculated as the ratio of the applied cyclic deviator stress ( $\sigma_d$ ) and resilient strain ( $\epsilon_r$ ). The  $\sigma_d$  and  $\epsilon_r$  values from a typical stress-strain cycle during the test are shown in Table 2. The average  $\sigma_d$  and  $\epsilon_r$  of the last five cycles of a loading sequence are used in  $M_r$  calculations. After  $M_r$  testing, UU shear strength testing was performed on each sample by applying a confining pressure of 34.5 kPa (5 psi) to the base material samples.

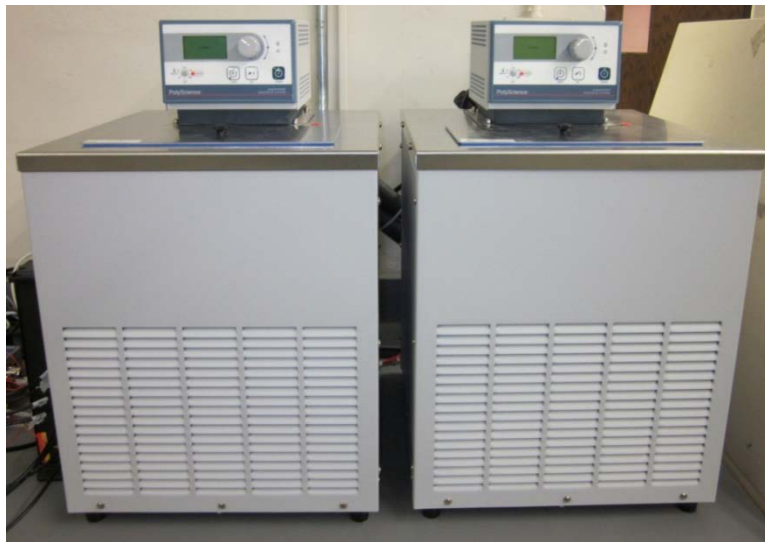
**Figure 26. Temperature control water baths used to freeze and thaw samples**

The tests were carried out by exposing four soil samples to two F/T cycles over a five day period. The samples were placed in a temperature controlled chest freezer (Figure 24) and then frozen and thawed by changing the temperature at the top and bottom of the samples using temperature controlled water baths (Figure 26). The programmable water baths used in this study had an operating range of  $-30^{\circ}\text{C}$  to  $+200^{\circ}\text{C}$ ; were adjustable to  $\pm 0.01^{\circ}\text{C}$ ; and were filled with a 50% ethylene glycol-water solution. Insulating tape was wrapped around the flexible tubing between the water baths and the temperature control end plates to help reduce temperature variations in the solution. The target top and bottom of the sample temperatures (Figure 27) were programmed into the water baths and the actual temperatures were measured during the test. An example of the measured temperatures at the top and bottom of the sample is shown in Figure 28.

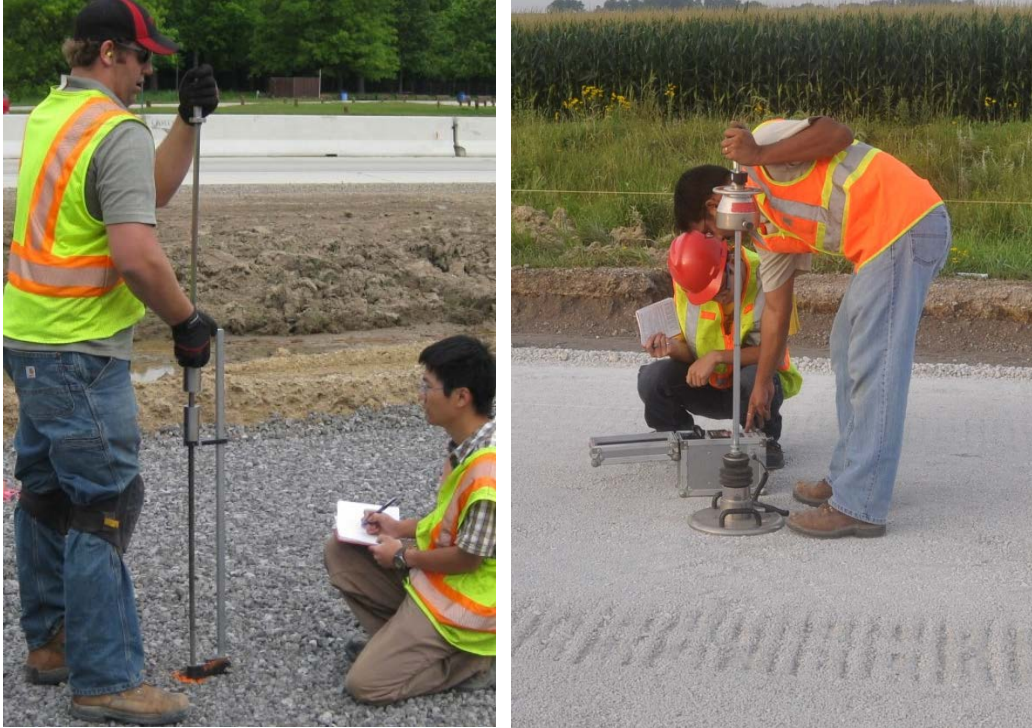
**Figure 30. DCP testing (left) and Zorn LWD testing (right)**

DCP tests (Figure 30) were performed in accordance with ASTM D6951-03 *Standard Test Method for Use of the Dynamic Cone Penetrometer in Shallow Pavement Applications* to determine dynamic penetration index (DPI) and calculate California bearing ratio (CBR) using Equation 6 or 7, as appropriate.

Zorn LWD tests were performed on subbase and subgrade layers to determine elastic modulus (Figure 30). The LWD was setup with 300 mm diameter plate and 71 cm drop height. The tests were performed following manufacturer recommendations (Zorn 2003) and the elastic modulus values were determined using Equation 8:

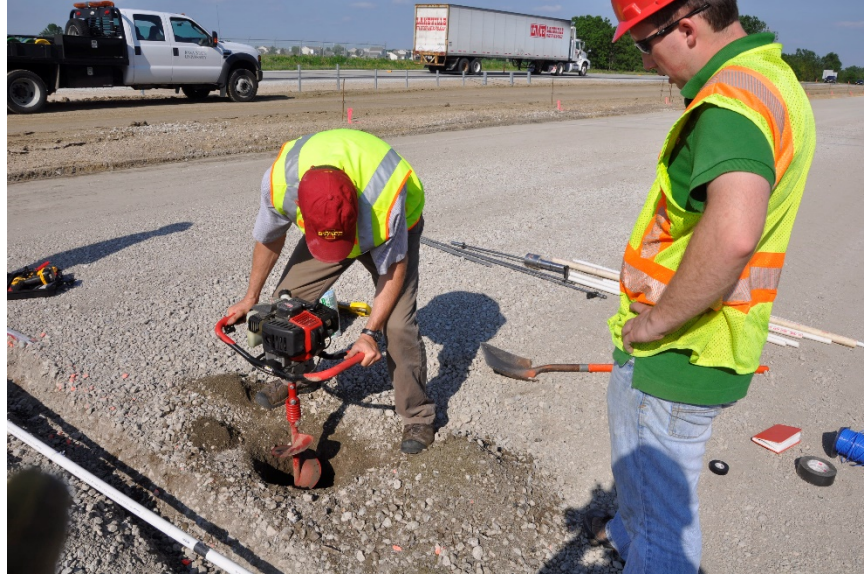
**Figure 35. Preparation of a vertical hole to install temperature sensors down to about 1.2 m below surface**

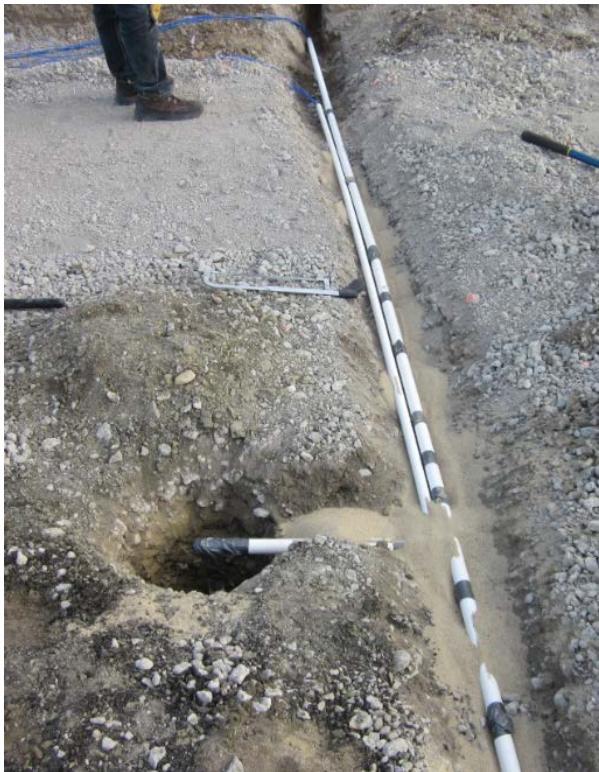
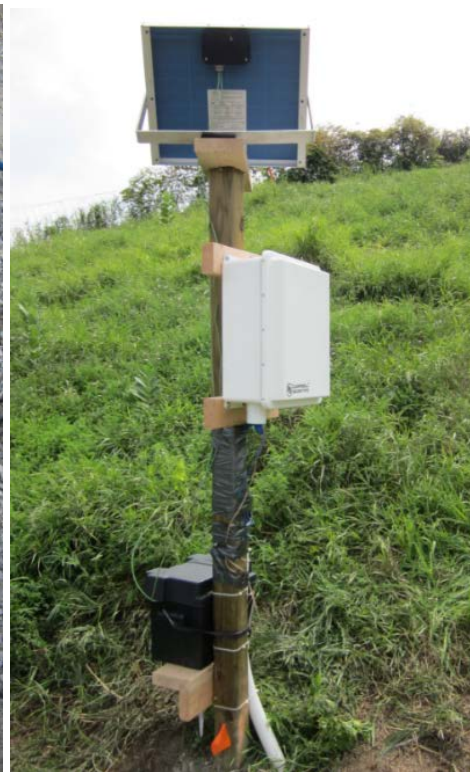
**Figure 36. Vertical and horizontal temperature probes (left) and temperature data acquisition setup (right)**

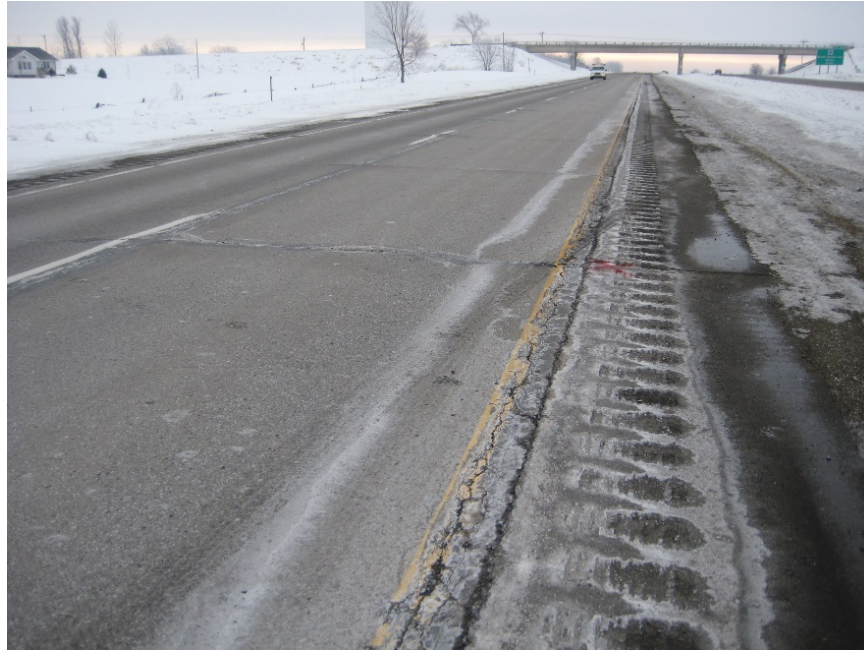
**Figure 70. The existing pavement on US 30 EB showing severe surface distresses**

- The existing pavement showed severe pavement distresses with reflective cracking and vertical upheave near joints, especially during winter. The Iowa DOT also reported incidents of damage to vehicle tires and problems with snowplow blade contact.
- Initial field investigations by the Iowa DOT rated the ride quality of the pavement section as “poor” based on pavement condition index (PCI) ranging between 54 and 56 on a 0-100 scale

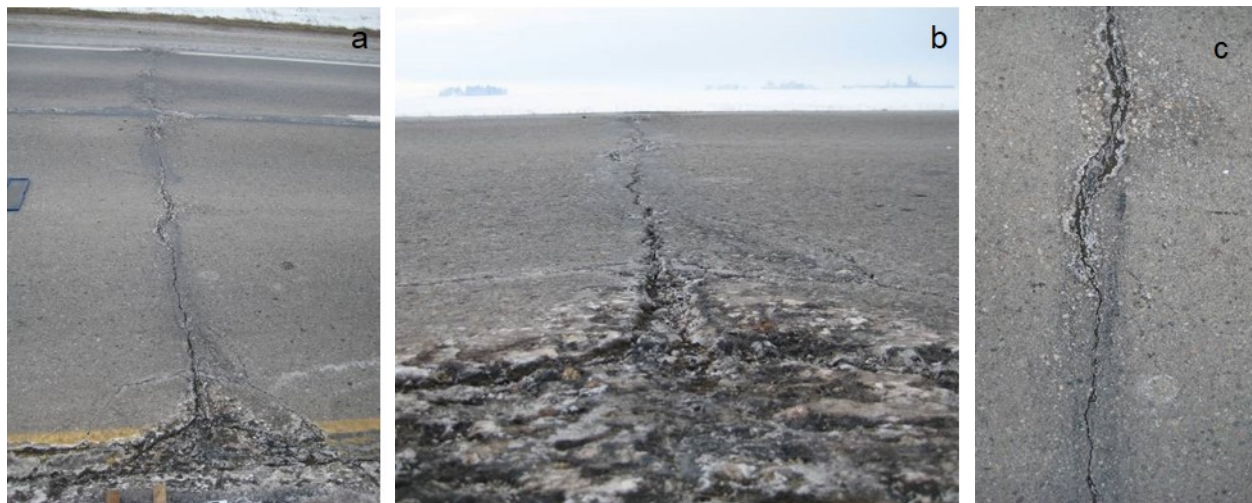
**Figure 78. Joint at mile 140.80: Isometric view (a); profile view looking south (b); top view of joint section (c) (03/04/2010)**

Two joints located in the eastbound lane at mile posts 140.79 and 140.80 were cored on March 4, 2010. A 254 mm (10 in.) diameter core was drilled at the joint at mile post 140.79 (Figure 77). The drilling was done into the PCC layer, but an intact sample was not obtained due to weak and deteriorated structure of concrete. Standing water was observed in the cored 254 mm (10 in.) diameter cavity (Figure 79). A reinforcing dowel was observed in the cavity and was removed. While surface corrosion existed, the structural integrity of the dowel was intact. A 102 mm (4 in.) diameter core was obtained on the PCC pavement and ATB interface (Figure 79). Standing water was also observed on the ATB layer.

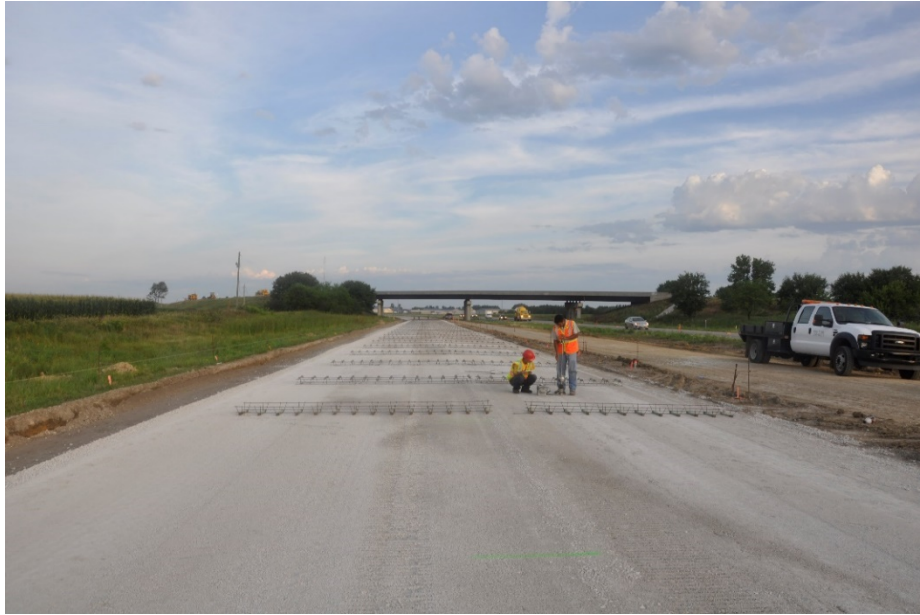
**Figure 88. Field testing on finished RPCC modified subbase layer (June 8, 2011)**

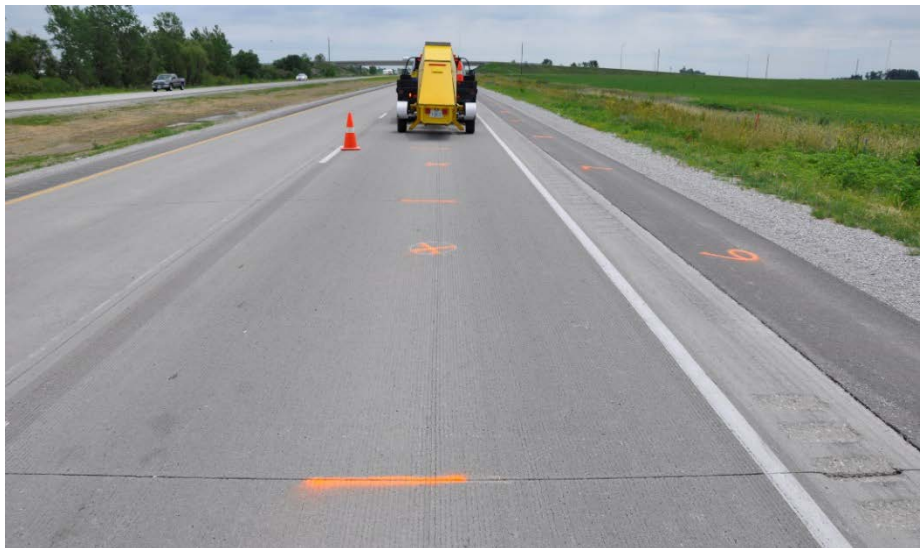
**Figure 89. Field testing on finished pavement surface (June 6, 2012)**

In situ DCP and LWD tests were conducted on the foundation layers and FWD tests were conducted on the pavement layer. Air temperatures were monitored during field testing, and temperature probes were installed at depth and transversely in the pavement foundation at one location. All testing was conducted on US30 EB lane near between Sta. 1394+00 and 1396+00. Pictures during testing on the RPCC modified subbase layer and the PCC surface layer are shown in Figure 88 and Figure 89.

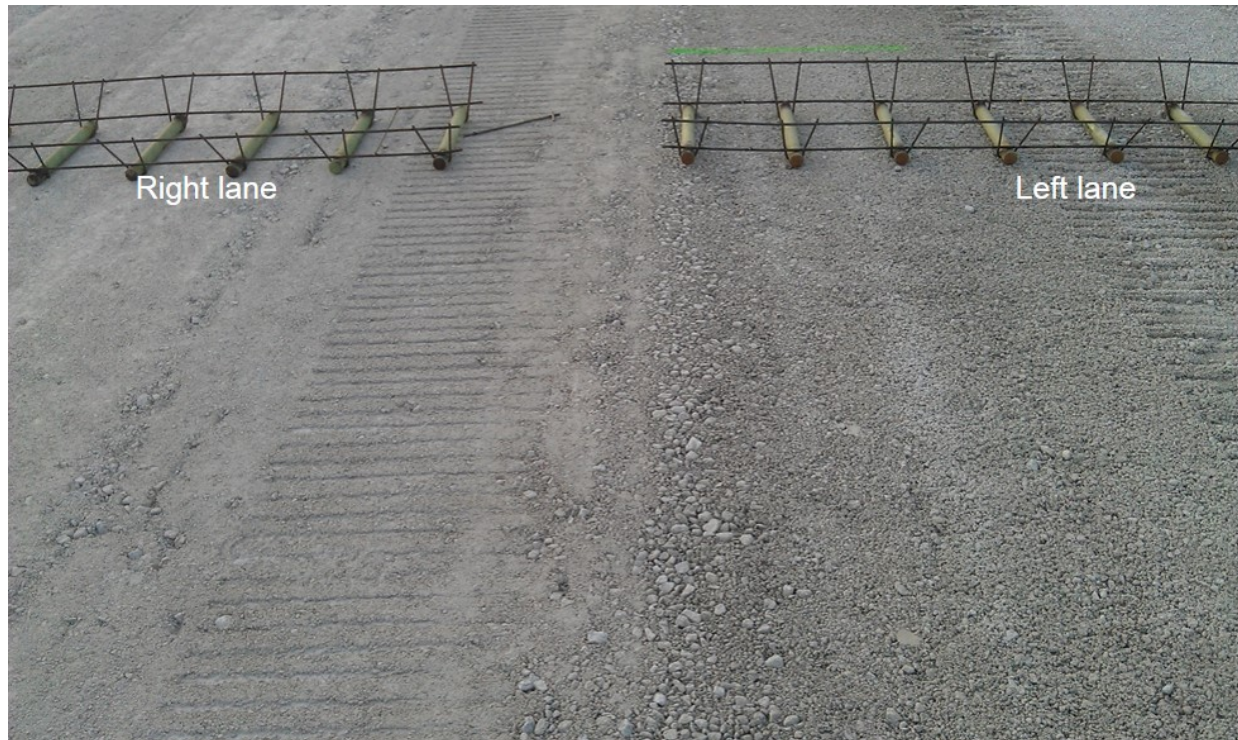
**Figure 94. RPCC modified subbase layer surface**

LWD tests were conducted transversely to capture the variability observed at the surface with aggregate segregation as shown in Figure 94 and Figure 95.  $E_{LWD}$  values on the right lane were comparatively higher than in the left lane. As can be seen in the figures, higher moduli values were in areas with more fines content. Figure 96 is a histogram of  $E_{LWD}$  values along with  $\mu$ ,  $\sigma$ , and COV statistics.

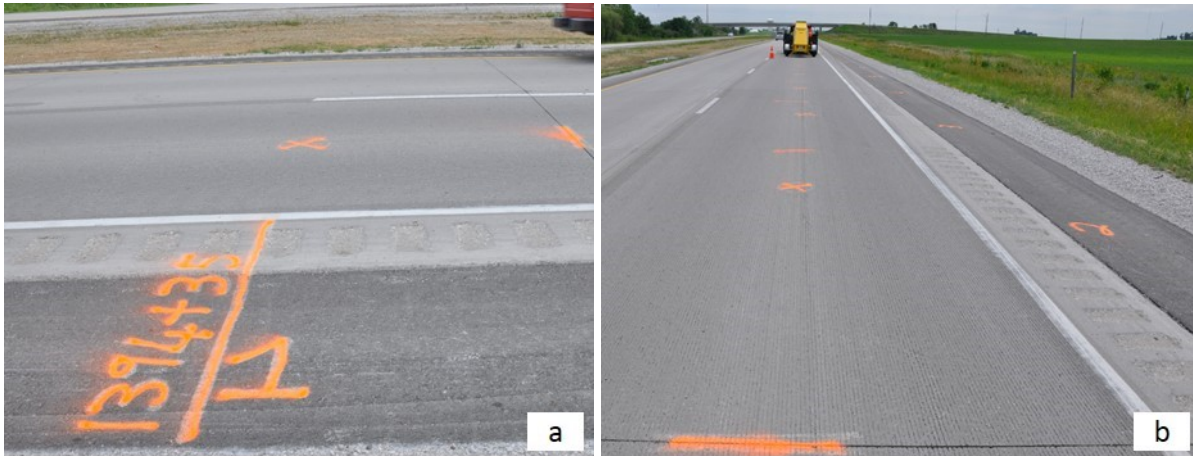
**Figure 97. Start point for FWD tests at 1394+35 (a) and a view from the start point (b)**

FWD tests were conducted on the pavement layer on June 6, 2012. Tests were conducted near the mid-panel and at joints (Figure 97). FWD  $D_0$ ,  $I$ ,  $k_{\text{FWD-Static-Corr}}$  values for tests conducted near mid panel, and  $D_0$ ,  $I$ , and  $\text{LTE}$  for tests conducted near joint are presented in Figure 98. A histogram of  $k_{\text{FWD-Static-Corr}}$  values is provided in Figure 99, which shows that the average  $k$  was about 37.1 kPa/mm with a COV of about 7%.
