# Improving the Foundation Layers for Concrete Pavements

## Jointed Concrete Pavement Rehabilitation with Injected High Density Polyurethane Foam and Dowel Bar Retrofitting – Pennsylvania US 422 Field Study

**August 2015**

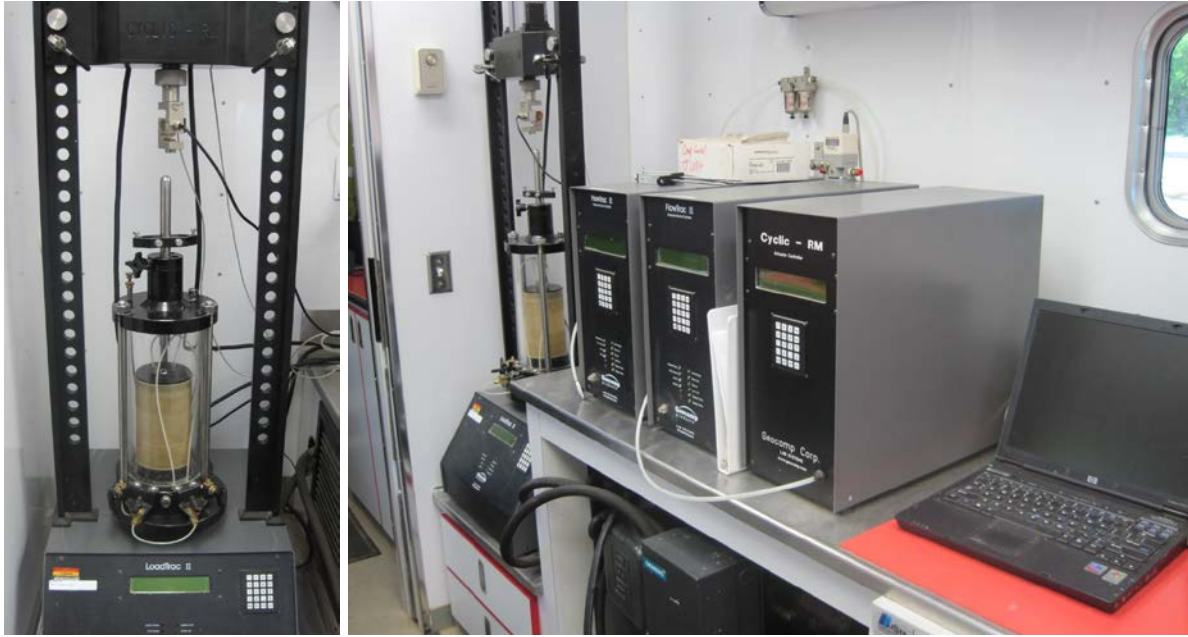
**Figure 1. Triaxial chamber and load frame (left) and computer setup (right)**

conditioning unit, and a computer with a network card for data acquisition. The system uses a real-time adjustment of proportional-integral-derivative (PID) controller to adjust the system control parameters as the stiffness of the sample changes to apply the target loads during the test.

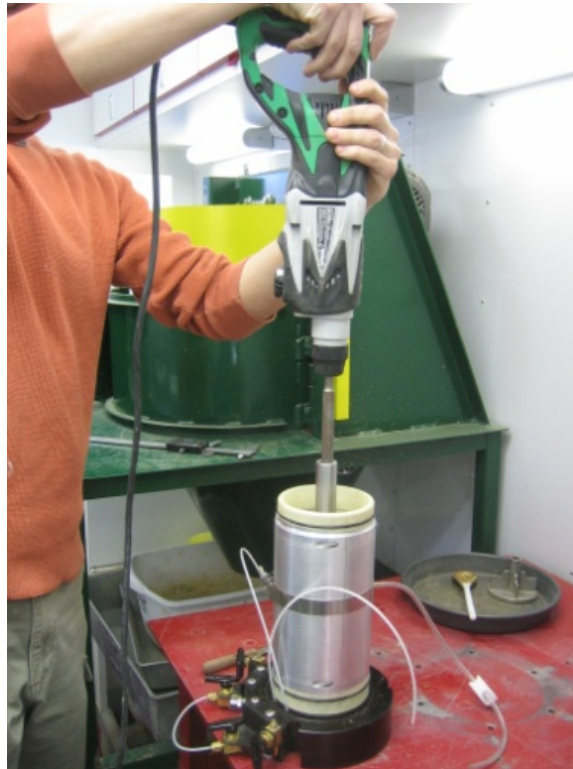
**Figure 3. Preparation of an OGS sample for laboratory  $M_r$  and UU testing**

OGS, OGS mixed with HDP foam (OGS+Foam), and HDP foam samples were tested in this research study. The OGS samples were compacted using a vibratory method. Vibratory compaction was achieved in five lifts of equal amount of material and thickness using an electric rotary drill hammer with a circular steel platen against the material (Figure 3).

The OGS sample was compacted in the field in a steel split mold as shown in Figure 3. The OGS+Foam sample was compacted in the field similar in a plastic mold in the same procedure followed for the OGS sample (Figure 4). Following compaction, the plastic mold was capped and HDP foam was injected into the mold. After injecting a sufficient quantity of foam, pressure was applied on top of the sample cap for some time (until the foam hardened) to simulate the confinement effect under the pavement.

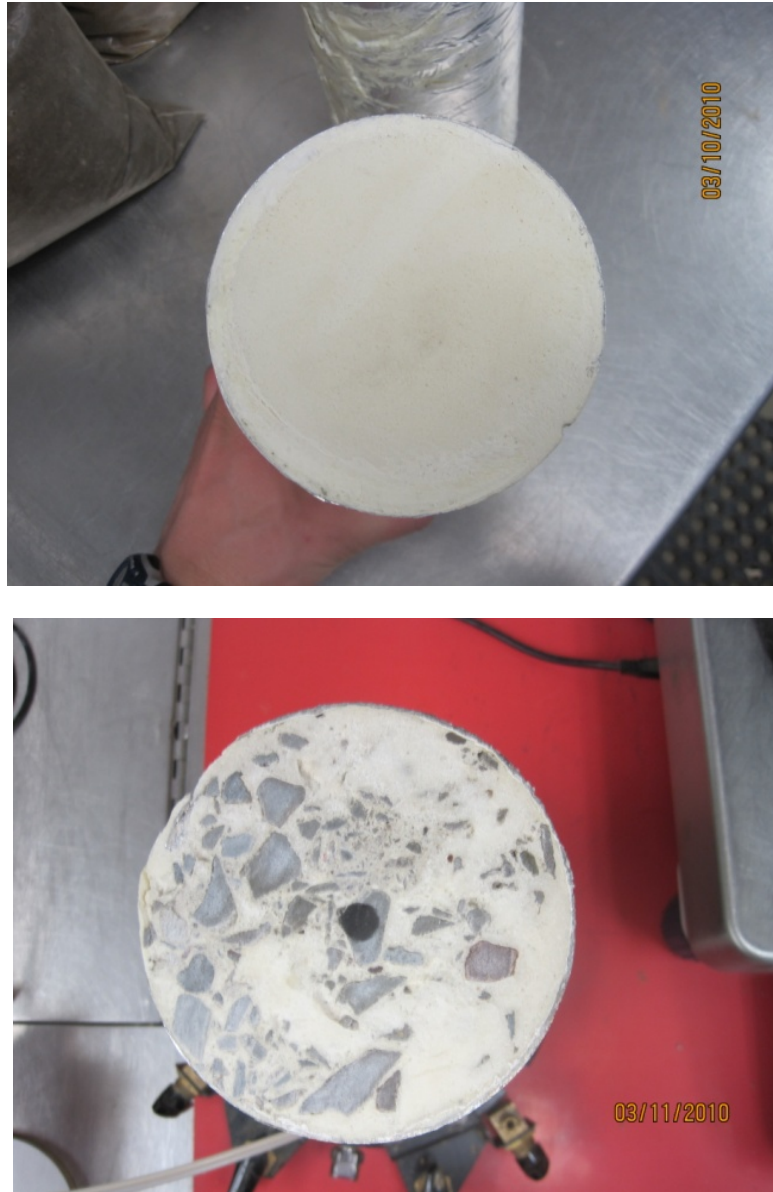
**Figure 5. Top view of HDP foam (top) and OGS+Foam mixture (bottom) samples**

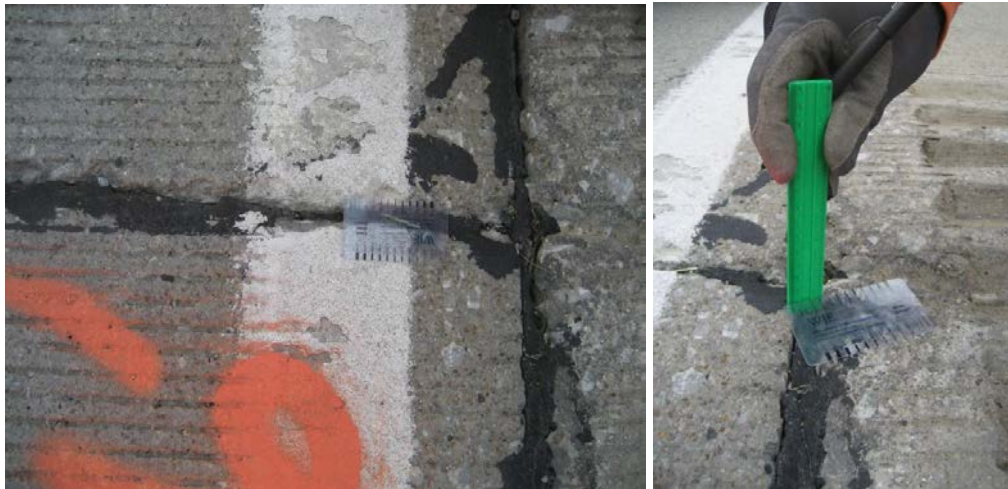
**Figure 9. Crack width (left) and fault (right) measurements**

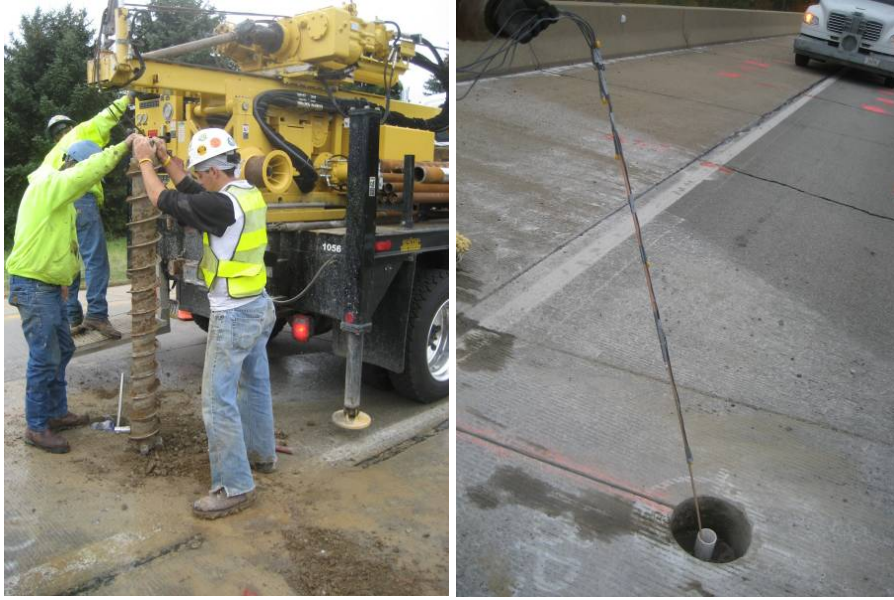
**Figure 10. I-button installation**

The I-buttons were taped at marked locations on the wooden stick so that the sensors would be located at approximately 0.25 m (10 in.); 0.31 m (12 in.); 0.45 m (18 in.); 0.61 m (24 in.); 0.91 m (36 in.); and 1.52 m (60 in.) beneath the pavement surface. A silty soil and silica sand slurry was mixed and poured into the plastic pipe, then the concrete core hole was patched and sealed with cement grout.

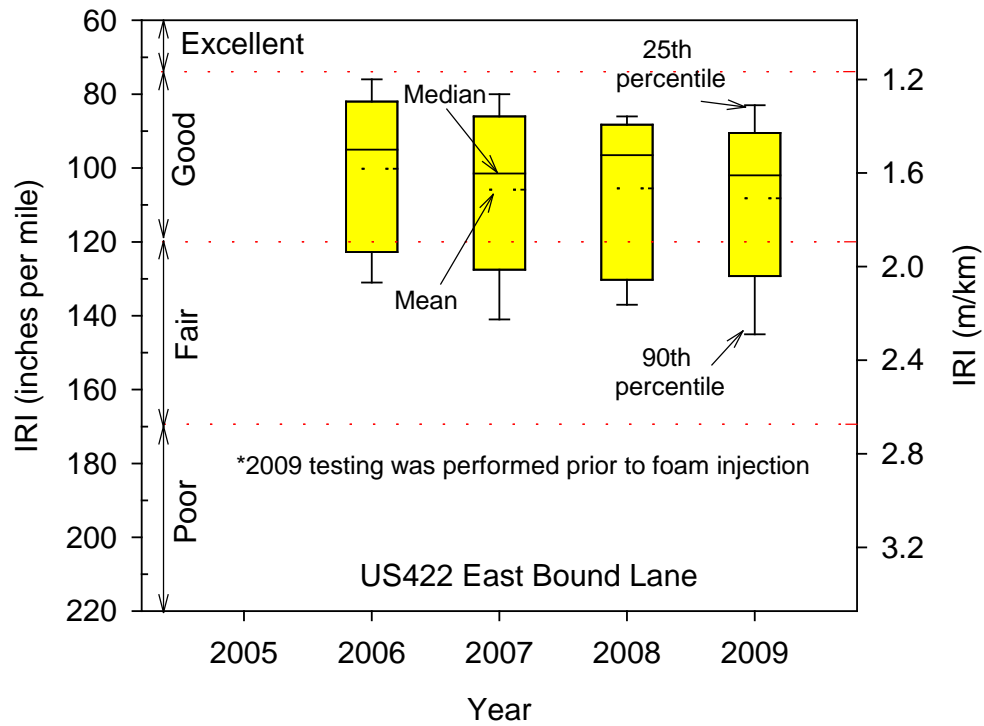
**Figure 13. Box plots of IRI measurements on US 422 EB (top) and WB (bottom) lanes from 2005 to 2010**

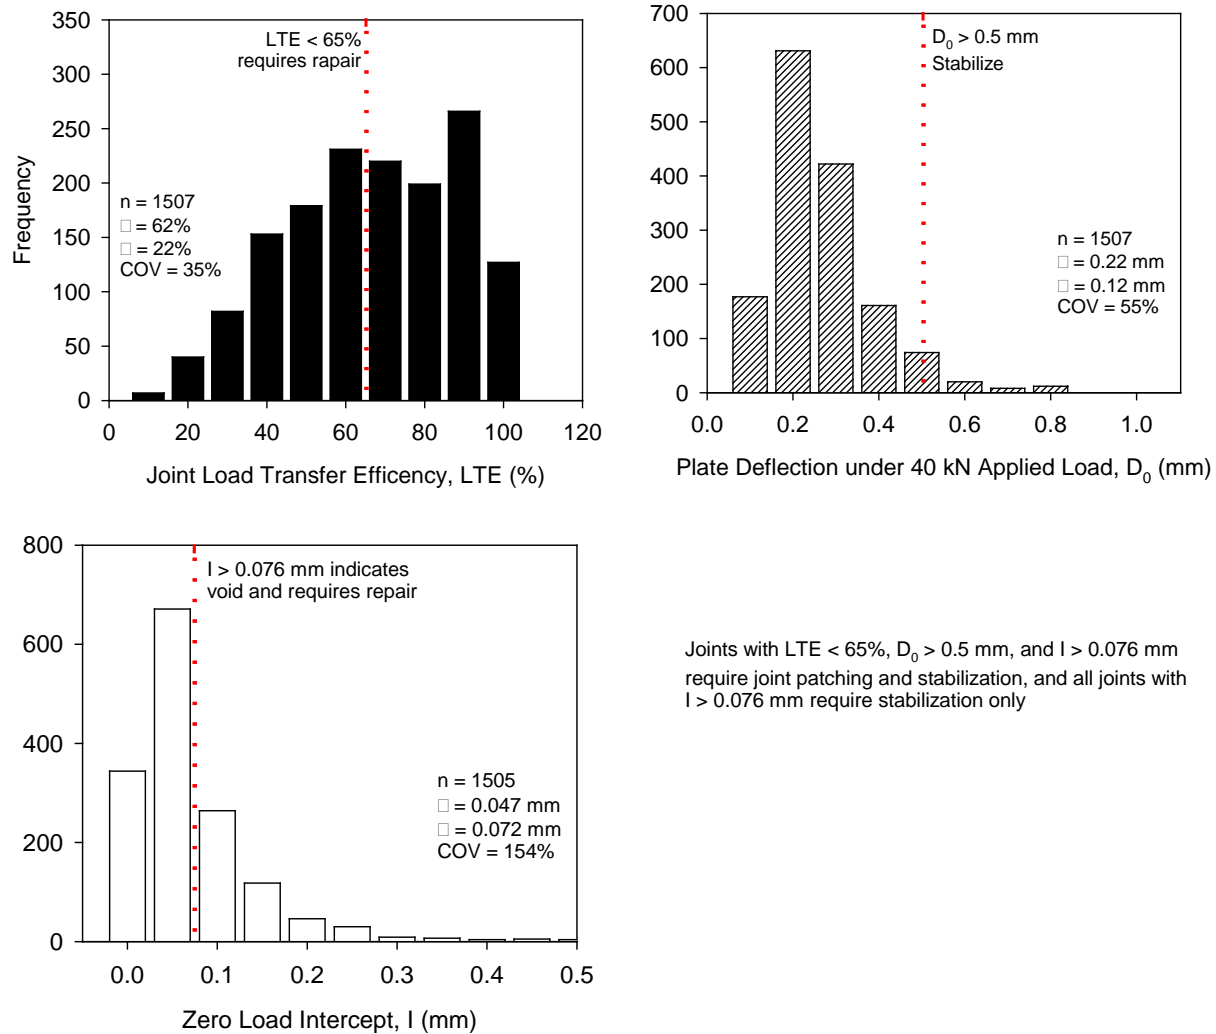
**Figure 16. Histogram of pre-stabilization FWD test results: joint LTE (top left),  $D_0$  under loading plate at 40 kN applied load (top right), and  $I$  (bottom left)**

LTE and I measurements from over 1500 test locations obtained before stabilization in May 2009 are presented in Figure 14 and Figure 15, respectively. Histograms of  $D_0$ , LTE, and I-values are shown in Figure 16. Summary statistics of the measurements, i.e., mean ( $\mu$ ), standard deviation ( $\sigma$ ), and coefficient of variation (COV), are provided in Figure 16. Based on these test results and the criteria outlined above per Penn DOT (2011), 40 locations qualified for both foam injection and patching, and 271 locations qualified for foam stabilization only.

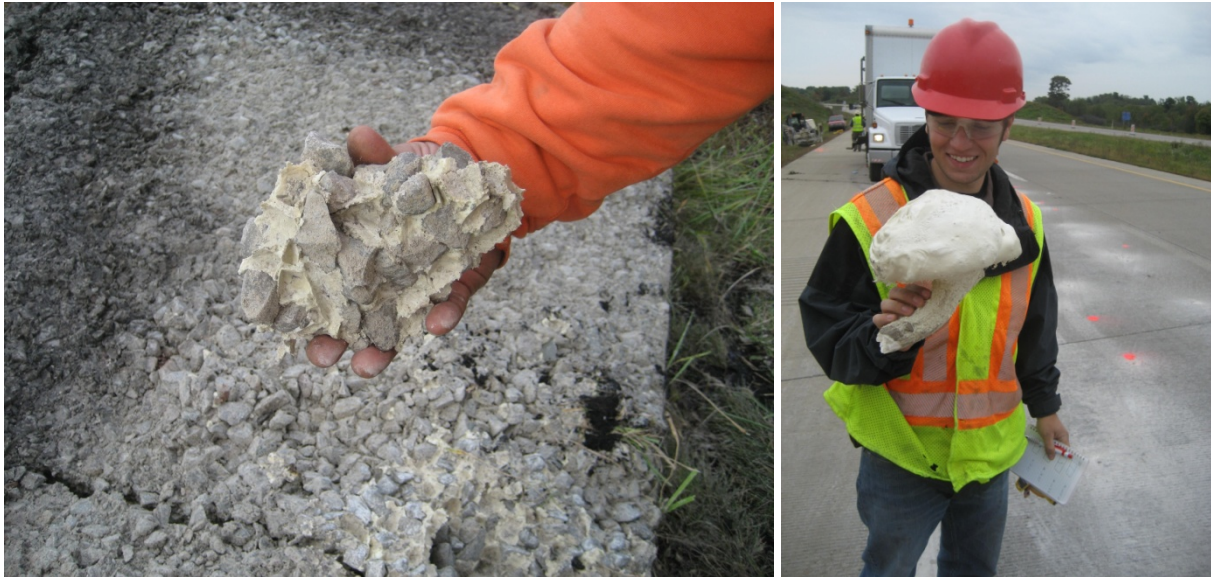
**Figure 18. Foam+aggregate mixture (left) and HDP foam ejected through a hole drilled in the pavement (right)**

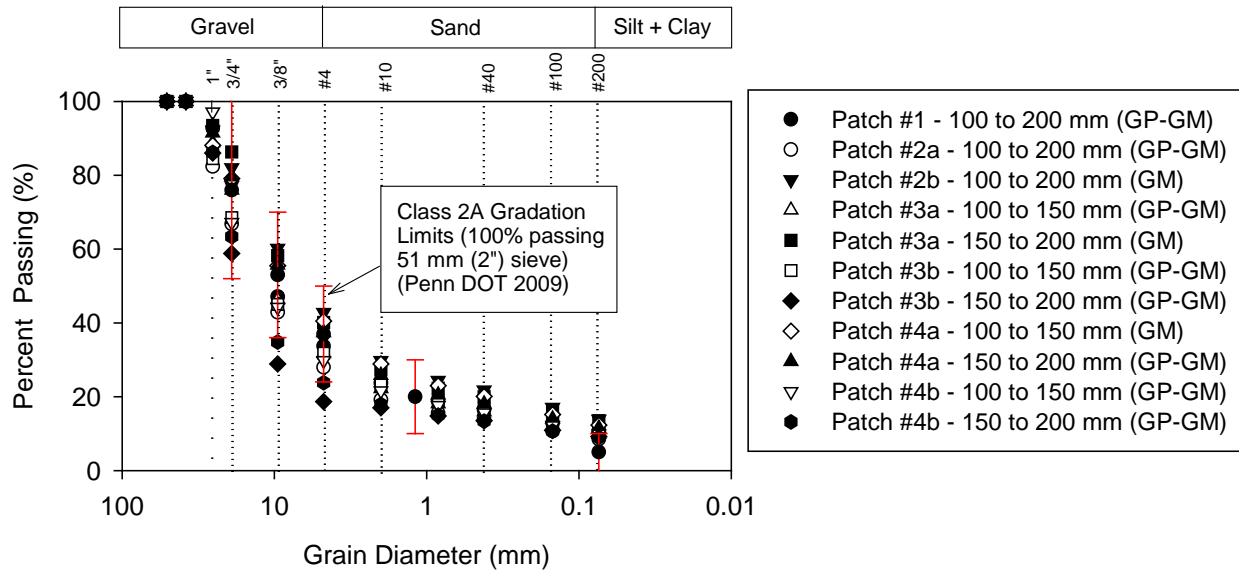
**Figure 20. Particle size distribution curves for 2A material from TS1/TS2**

Particle size distribution curves of OGS and 2A materials obtained from different depths from each section are provided in Figure 19 and Figure 20, respectively. The gradation specification limits are also provided in these figures for reference.

Particle size distribution curves of 2A materials (Figure 20) indicate that 4 out of the 11 samples collected were outside the gradation specification limits; 6 out of the 11 samples contained percent fines content greater than the maximum 10% specification limit for (Figure 23);  $D_{10}$  of the samples collected were less than the minimum 0.07 mm for 5 out of the 11 samples collected, while  $D_{60}$  were within the specification limits for all the samples collected. All the samples collected were outside the specification limits for  $c_u$  and  $c_c$ . The classification of the 2A materials varied from GM to GP-GM according to the USCS and was A-1-a according to the AASHTO classification system.

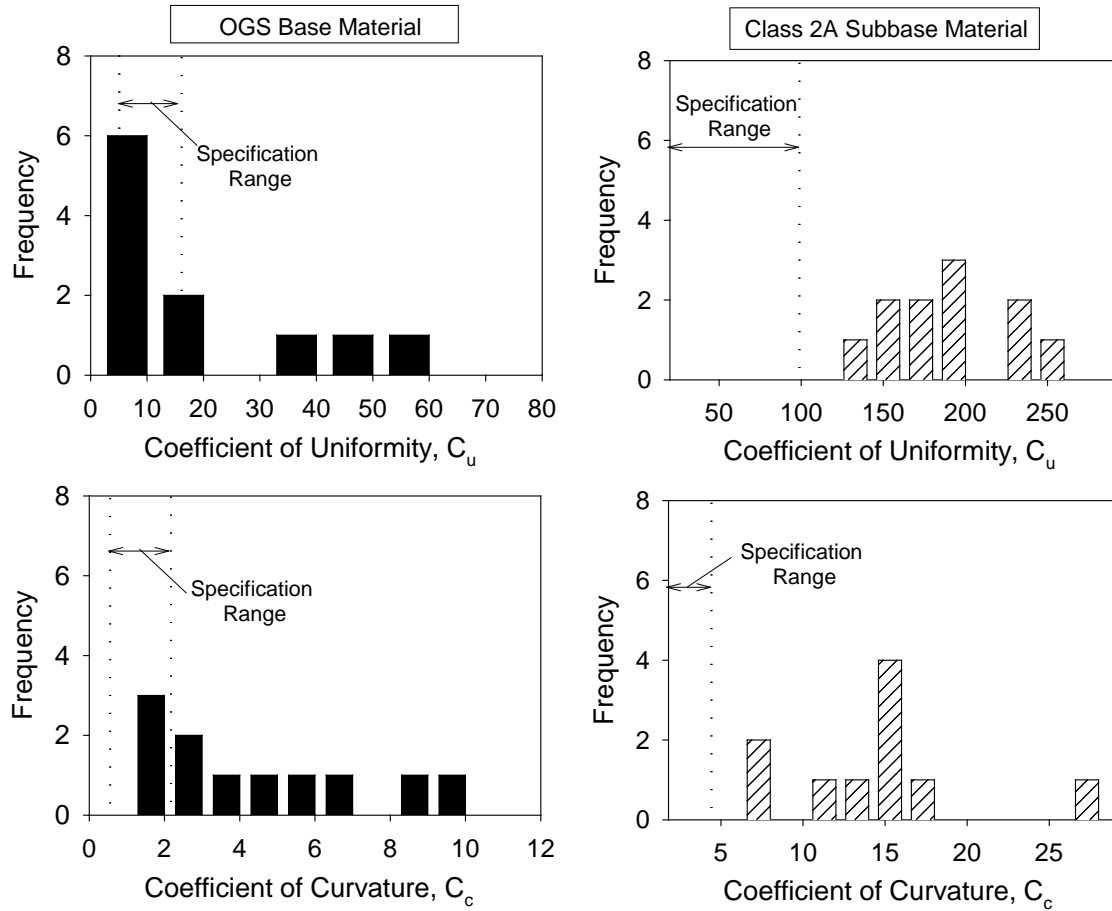
**Figure 22. Histograms of gradation parameters  $c_u$  and  $c_c$  for OGS and Class 2A materials**

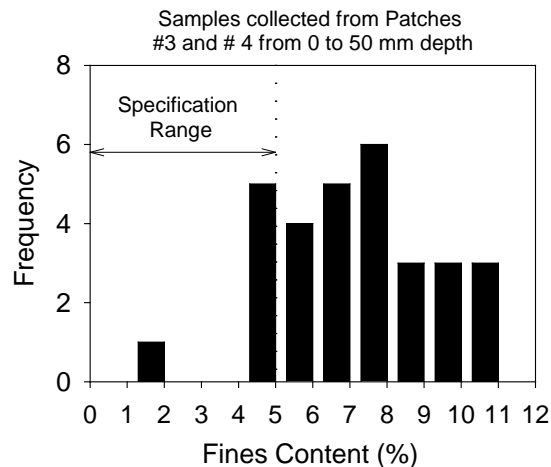
**Figure 23. Histogram of fines content for OGS samples from TS2-3 and TS2-4**

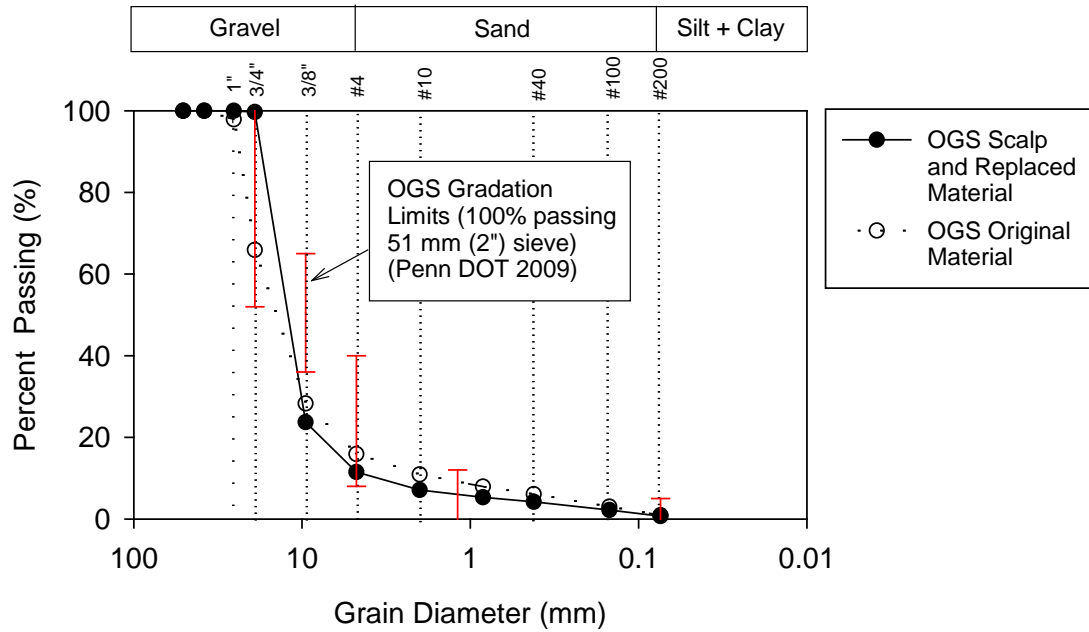
**Figure 25. Particle size distribution curves of OGS material before and after scalp and replace procedure (for material retained on 19 mm (3/4 in.) sieve)**

The gradation of the OGS samples used for  $M_r$  and UU tests was modified to meet the AASHTO T-307 standard procedure following a scalp and replace procedure (of material retained on 19 mm ( $\frac{3}{4}$  in.) sieve). The particle size distribution curves of the OGS material before and after the scalp and replace procedure is shown in Figure 25.

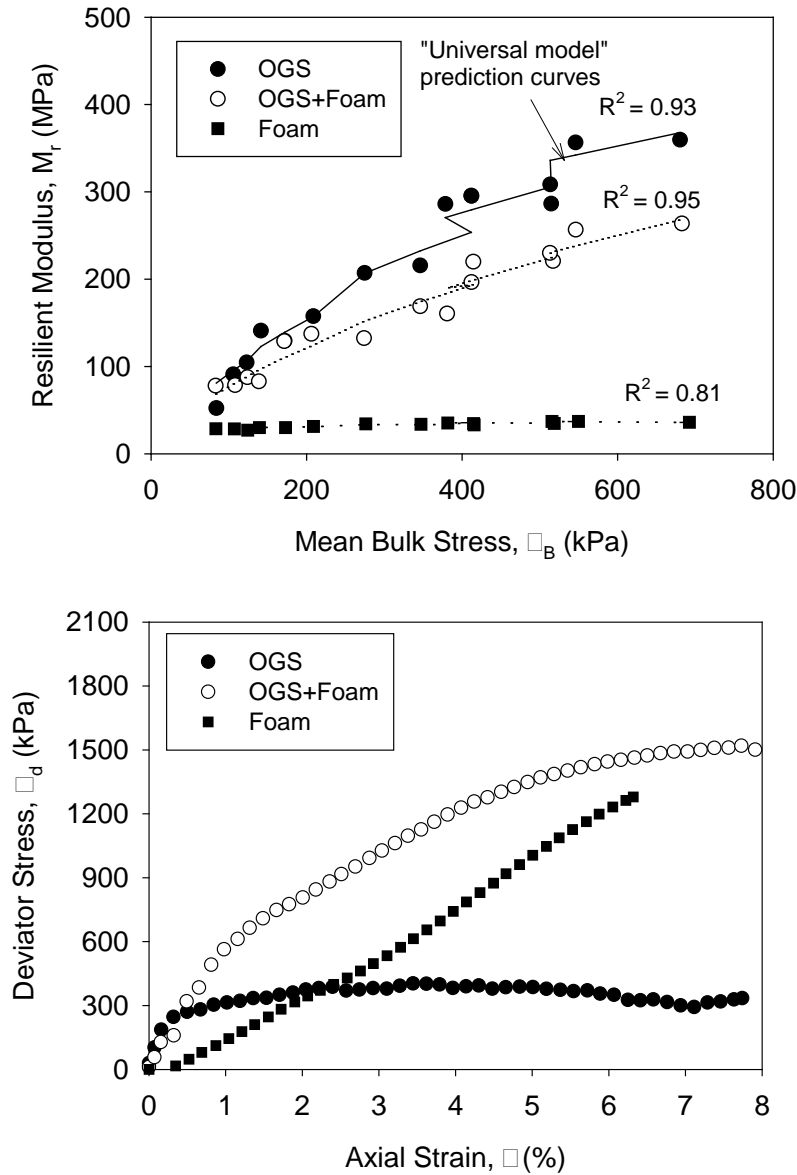
**Figure 29. Bulk stress versus resilient modulus (top) and stress-strain curves from UU tests (bottom) for OGS, OGS+Foam, and foam samples**

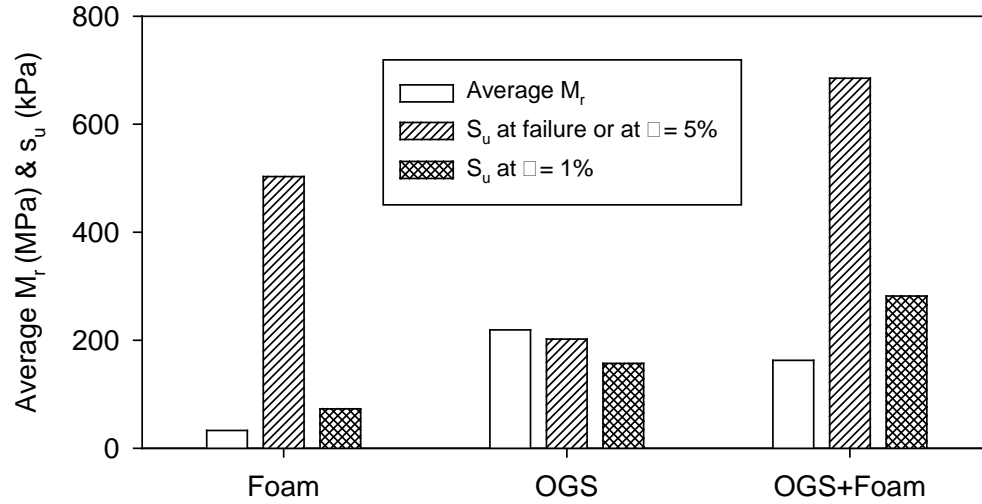
**Figure 30.  $M_r$  and UU test results of foam, OGS, and OGS+Foam samples**

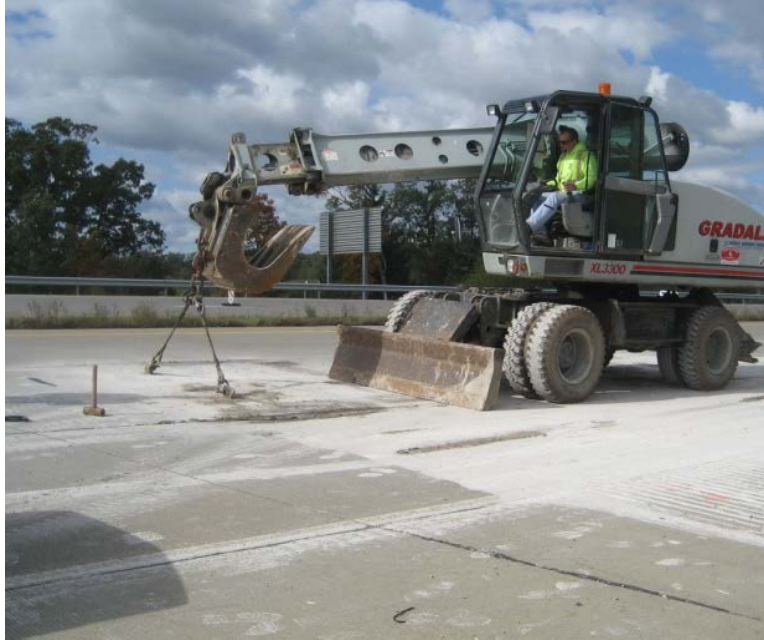
**Figure 32. TS1: Crane lifting the PCC surface layer of a patch area**

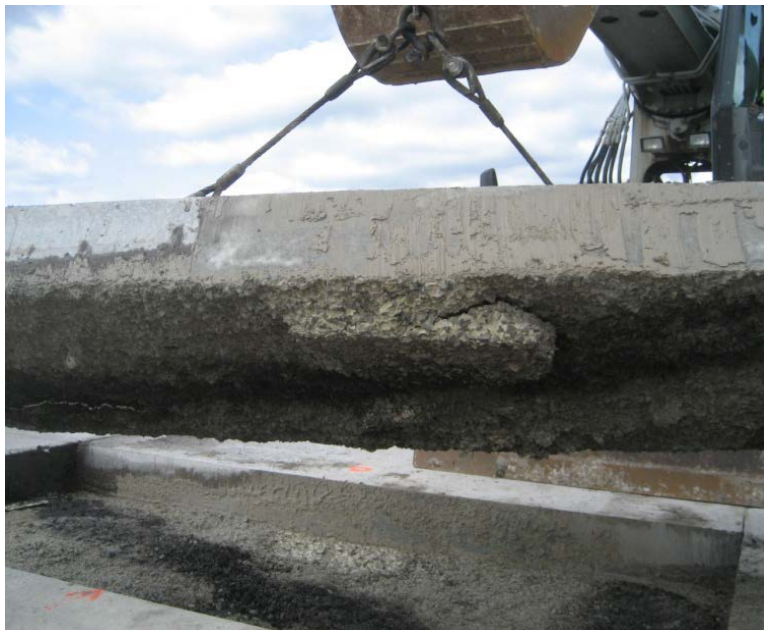
**Figure 33. TS1: Bottom of the PCC surface layer in the patch area with treated subbase layer**

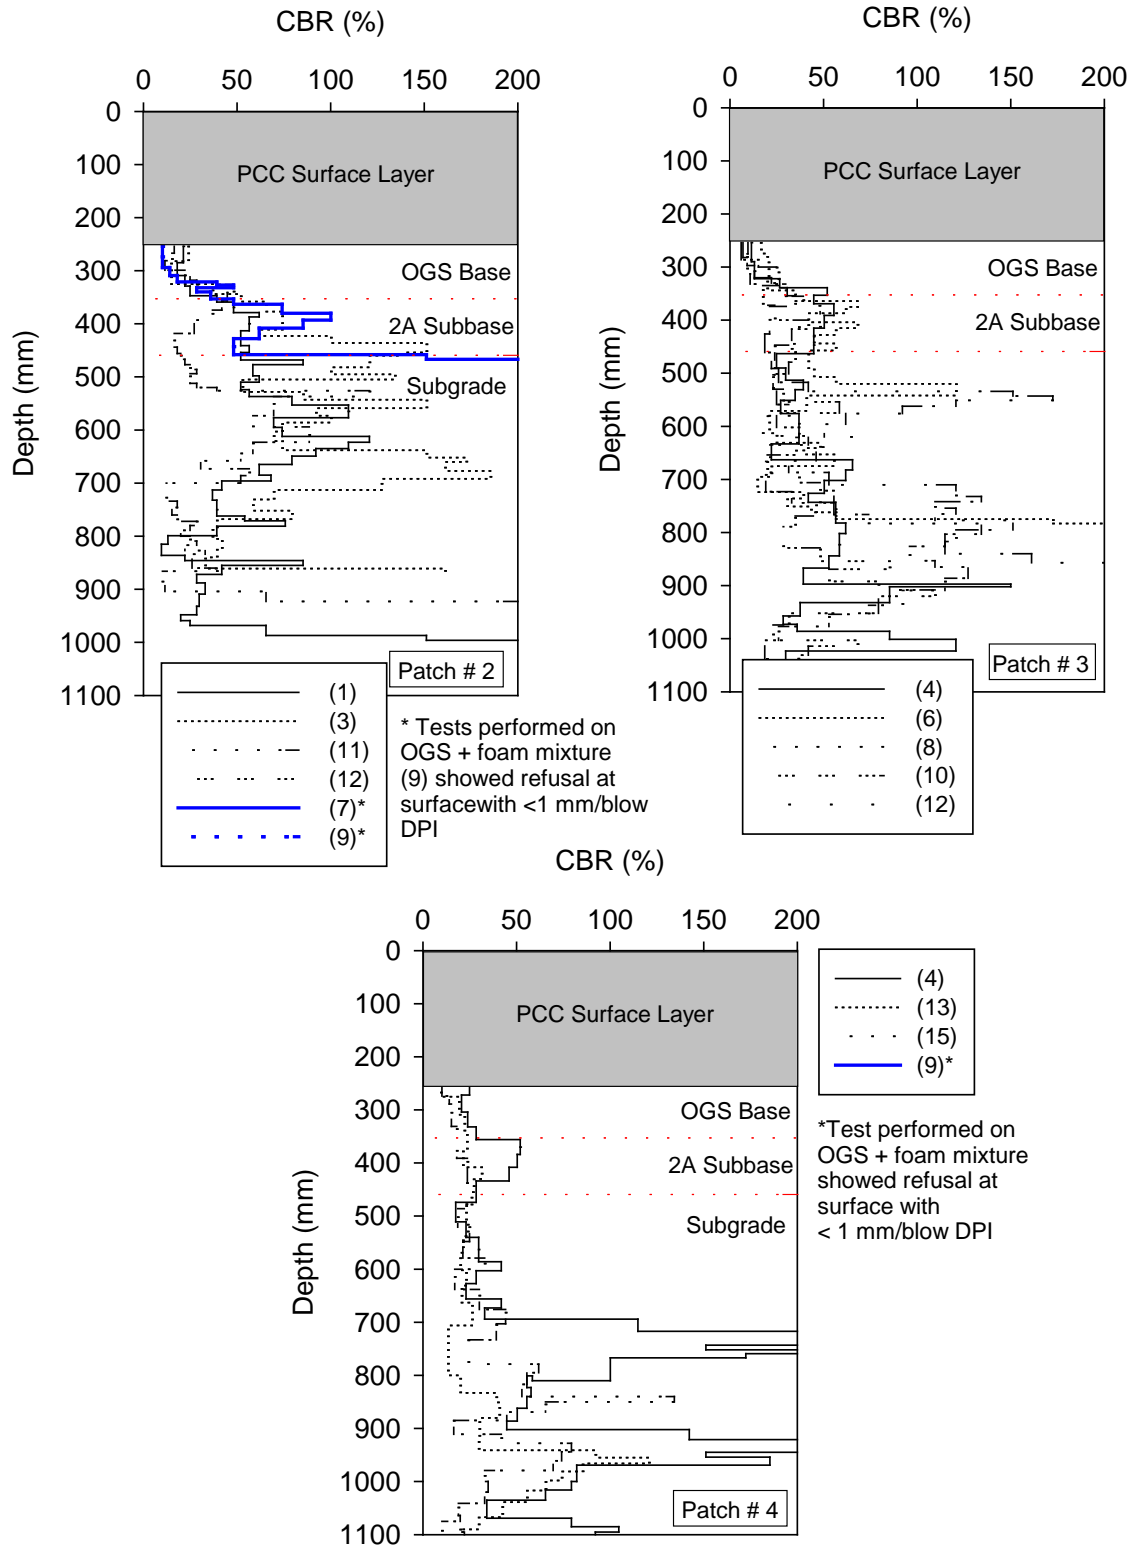
Figure 37. DCP-CBR profiles from patches areas 2, 3, and 4

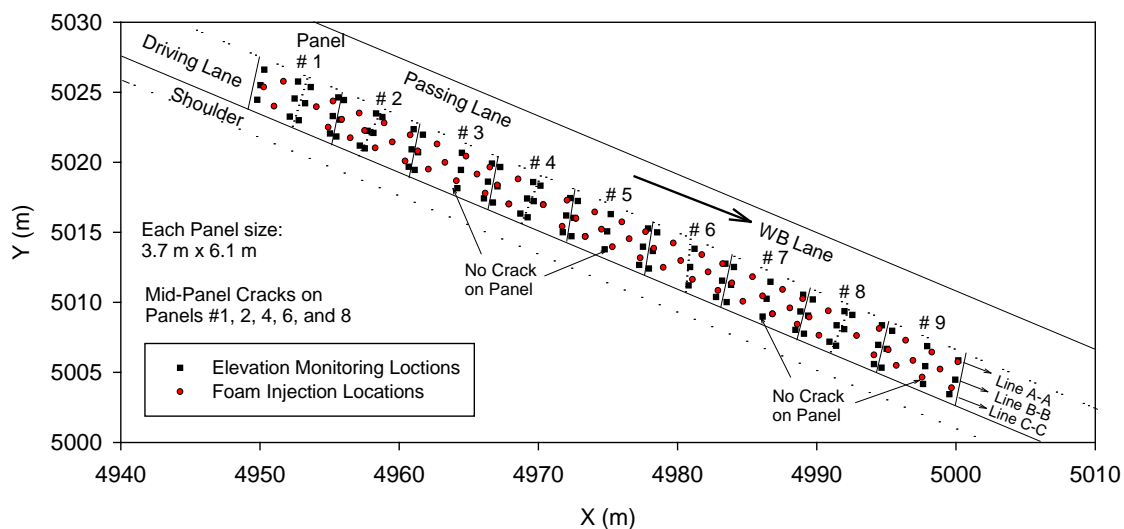
**Figure 38. TS6: Plan view of elevation monitoring locations, foam injection locations, and A-A, B-B, and C-C survey lines**

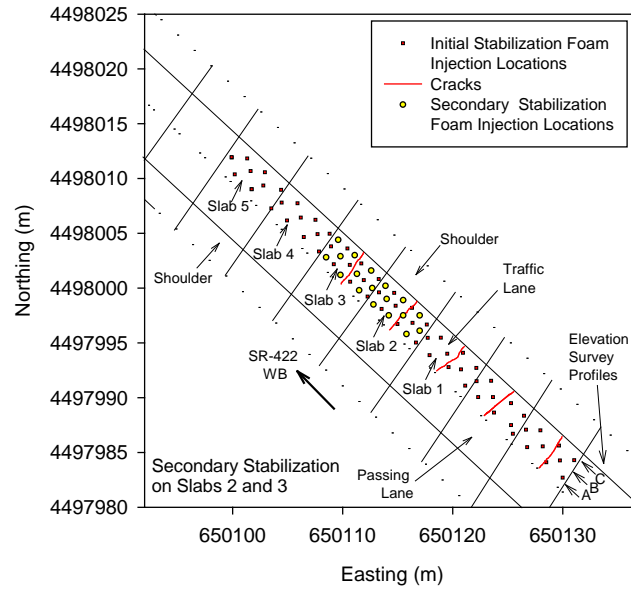
**Figure 40. TS7: Plan layout showing cracks, initial and secondary foam injection locations, and elevation survey profile lines**

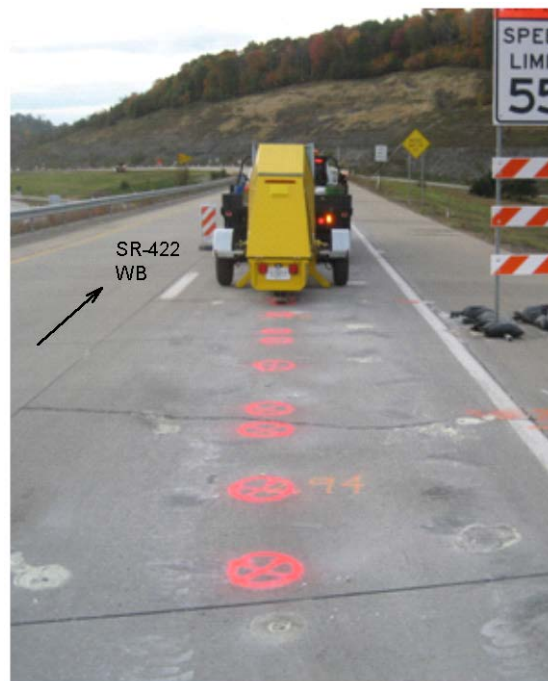
**Figure 58. TS7: Photograph showing FWD testing along the center lane**

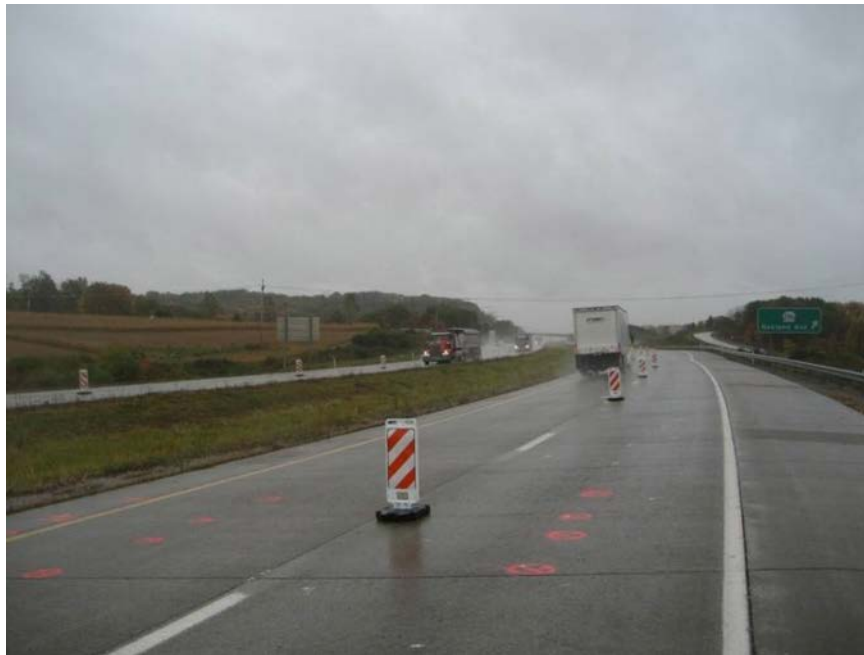
**Figure 60. TS8: Photograph showing test locations on driving and passing lanes**
