Coarse Aggregate Deterioration in Granular Surfaces and Shoulders

Iowa Highway Research Board
(IHRB Project TR-769)
Iowa Department of Transportation
(InTrans Project 18-683)

tech transfer summary

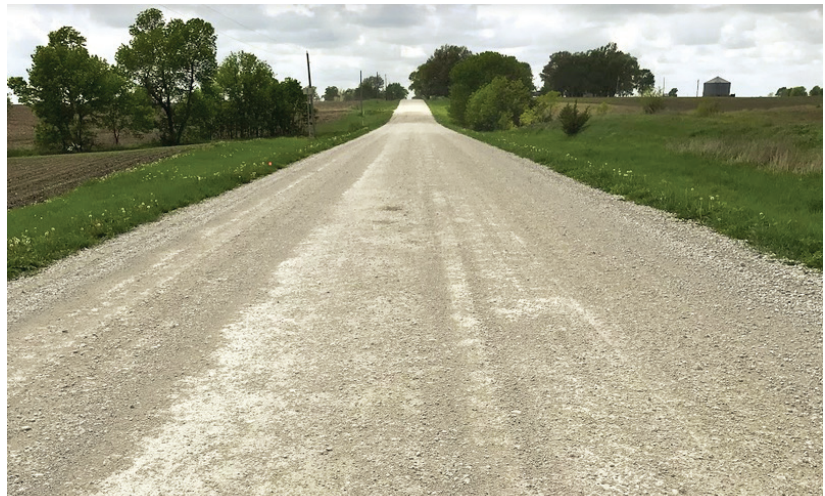
Granular-surfaced road in Iowa

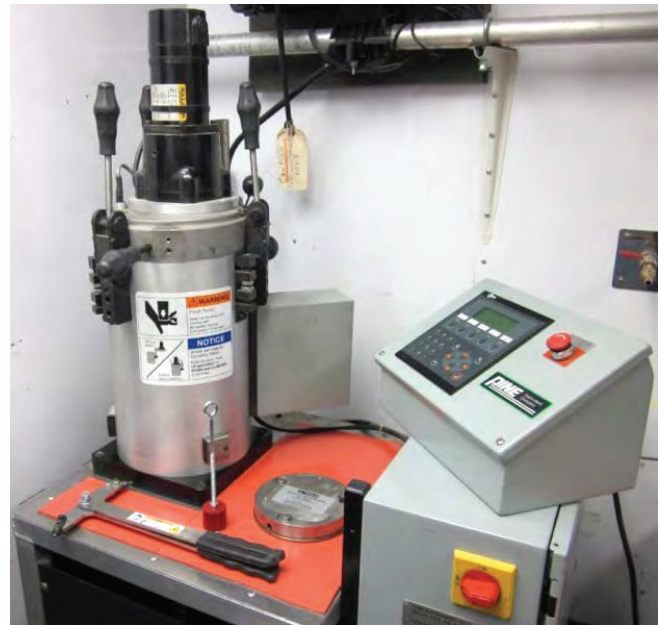
Gyratory compactor

Geotechnical tests included measurement of particle size distribution (PSD) through traditional sieve and hydrometer tests, gyratory compaction tests to simulate the effects of traffic loading, and 2D-image analyses to study changes in particle morphology during gyratory testing and field service.

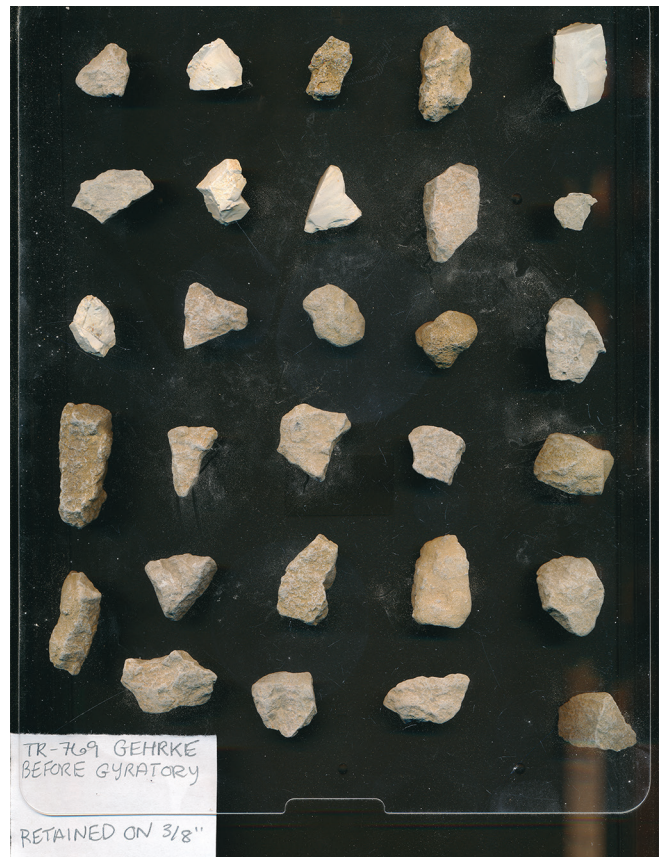
Coarse aggregate particles from Gehrke Quarry for 2D image analysis
