# Performance Evaluation of Concrete Pavement Granular Subbase— Pavement Surface Condition Evaluation

**Final Report**  
**July 2008**

**Sponsored by**  
Iowa Highway Research Board  
IHRB Project TR-554

IHRB Project TR-554  
CTRE Project 06-250

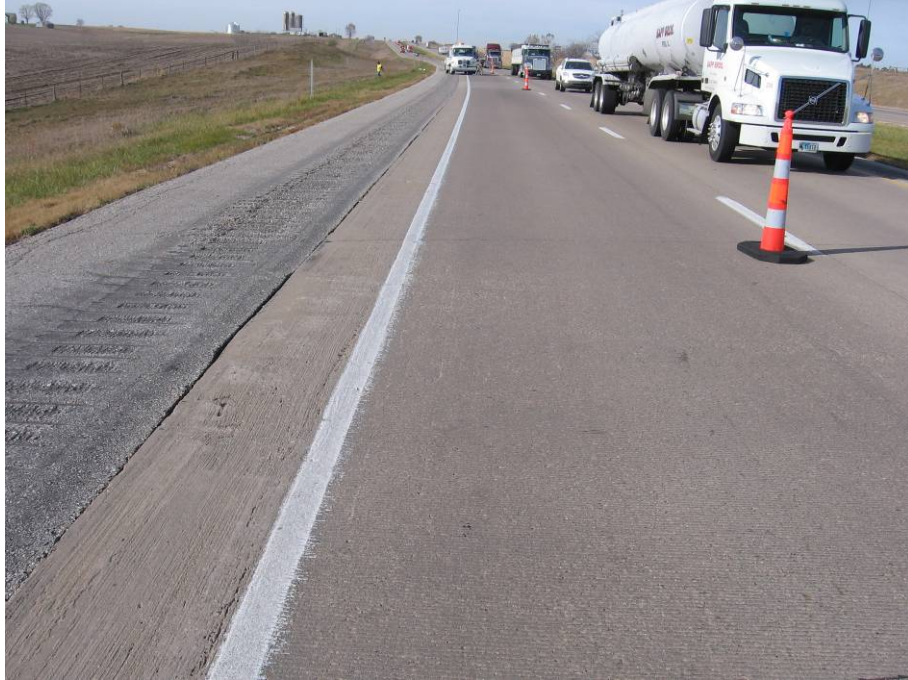
As seen in Table 27, and in Figures 19 and 20, few longitudinal and transverse cracks were observed in the surveyed field test sections. Although a large number of pictures were taken as part of the visual distress survey for individual test sections, some representative pictures are included here which are indicative of the overall conclusion. The predominant distresses exhibited along all the surveyed test sections are joint sealing damage, spalling, and popouts. Especially, the lane-to-shoulder separation and the lane-to-shoulder drop off as shown in Figures 21 and 22, respectively, are more often observed in RPCC test sections than virgin aggregate subbase test sections. These observations are consistent with those reported by Rollings et al. (2006), who concluded that the cause of the distresses between lane and shoulder is probably due to sulfate attack on the RPCC used as fill and base course.

**Figure 22. Picture of I-80 (E) pavement section in Cedar County (Mile Post No. 276.60–276.70)—RPCC subbase section**

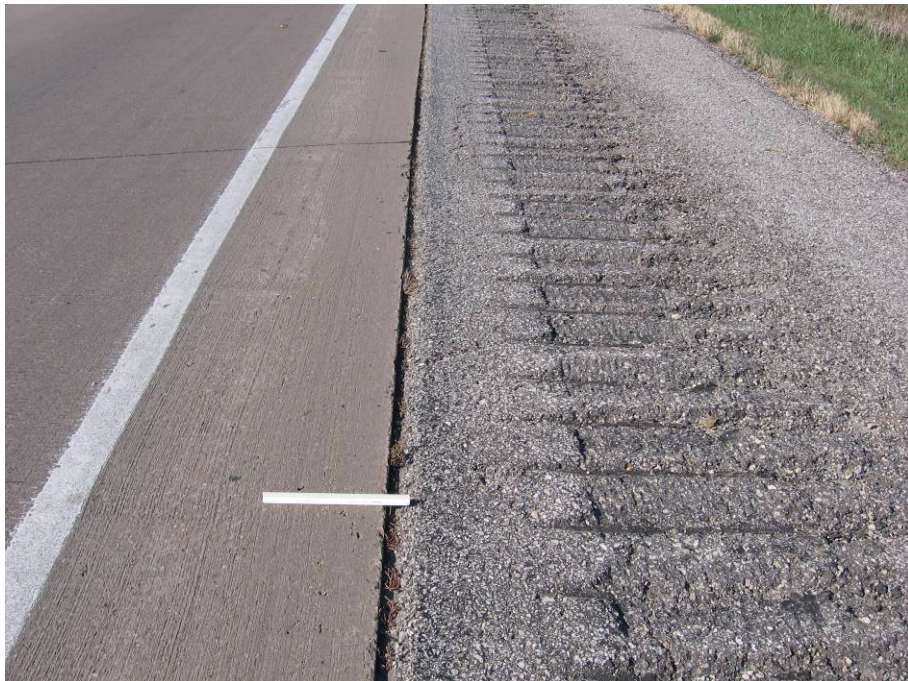
**Figure 23. Lane to shoulder separation on I-80 (W) in Cedar County (Mile Post No. 269.30–269.40)—RPCC subbase section**

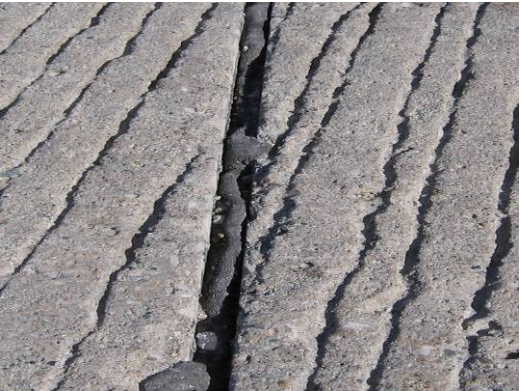
(b) Joint sealing damage of transverse joint at slab #6

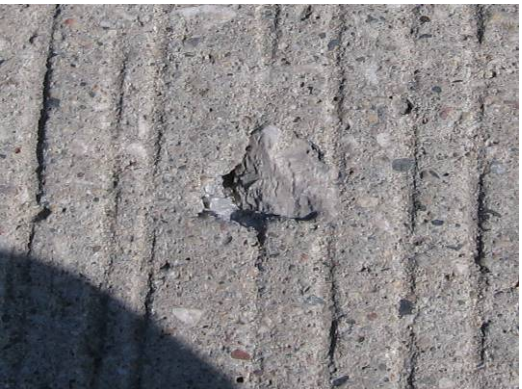
(c) Popout at slab #9

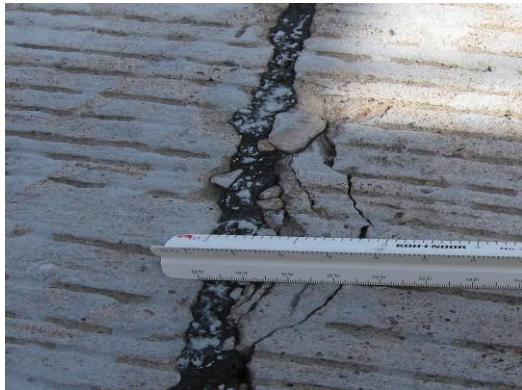
(c) Spalling of Transverse joint at slab #6

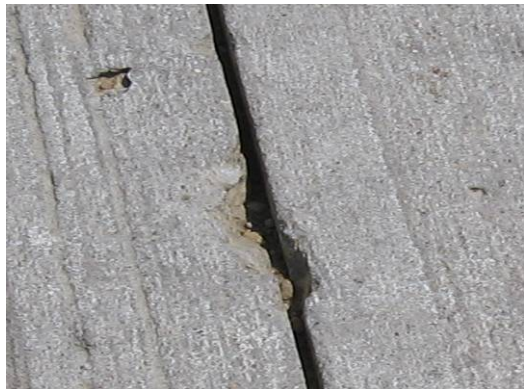
(c) Spalling of longitudinal joint at slab #15

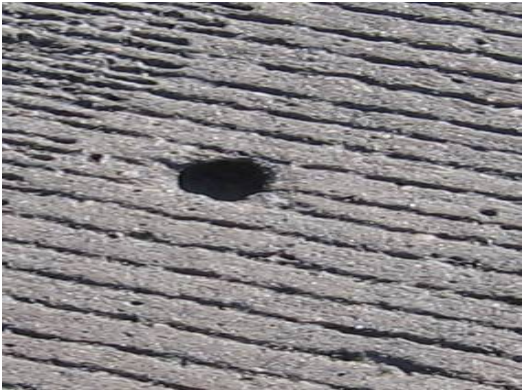
(a) Popout at slab #5

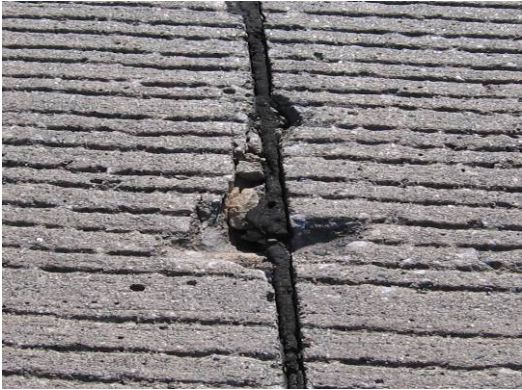
(c) Spalling of transverse joint at slab #9

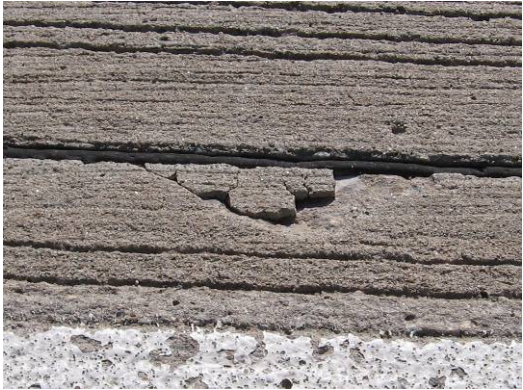
(d) Spalling of longitudinal joint at slab #13

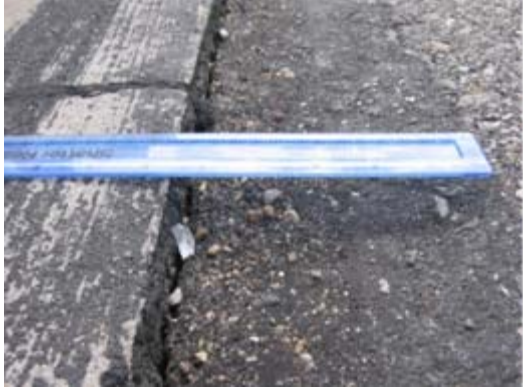
(d) Lane to shoulder drop-off at slab #20

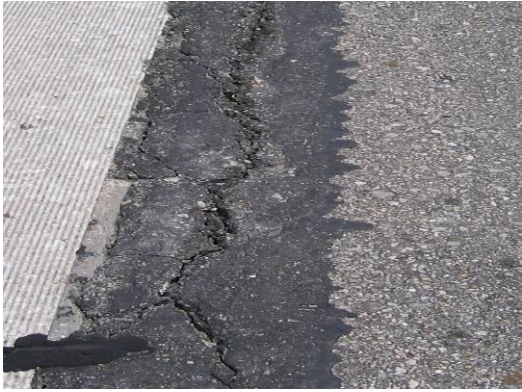
(d) Lane to shoulder separation at slab #18

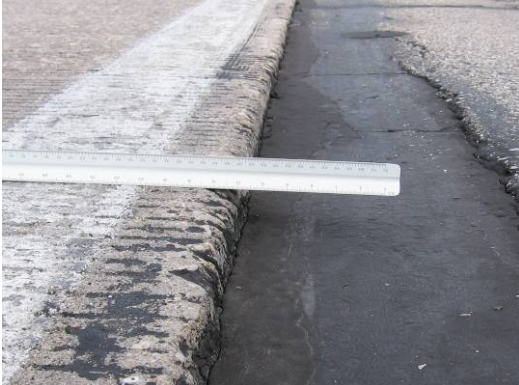
(a) Lane to shoulder drop-off at slab #1

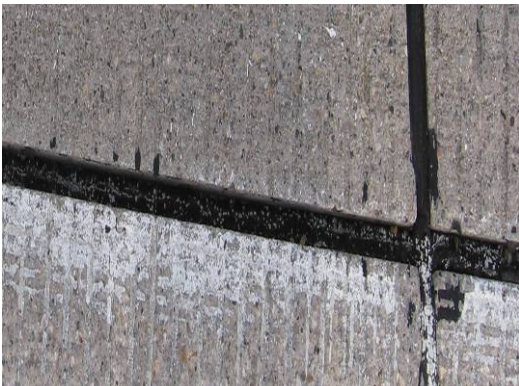
(b) Joint sealing damage of longitudinal joint at slab #5

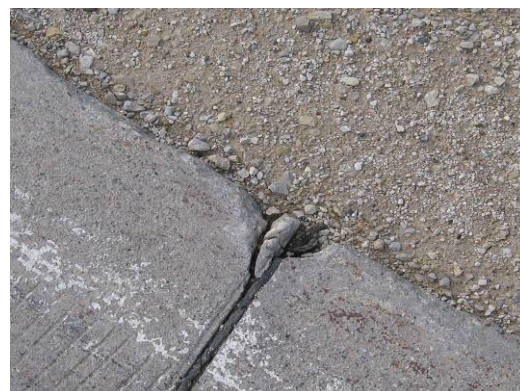
(c) Spalling of transverse joint at slab #14

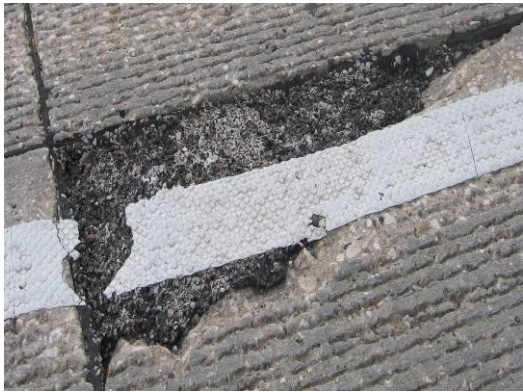
(d) Patch at slab #13

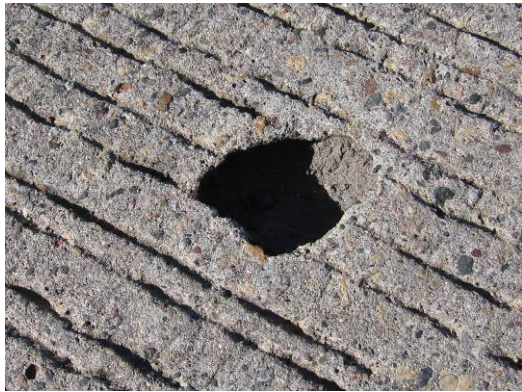
(d) Popout at slab #16

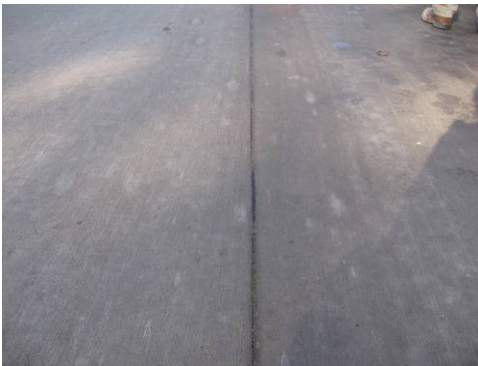
(a) Joint sealing damage of longitudinal joint at slab #1

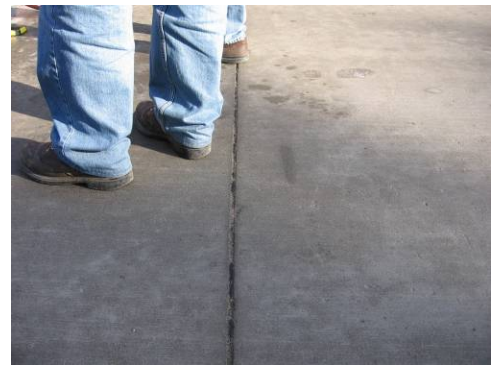
(b) Joint sealing damage of transverse joint at slab #1

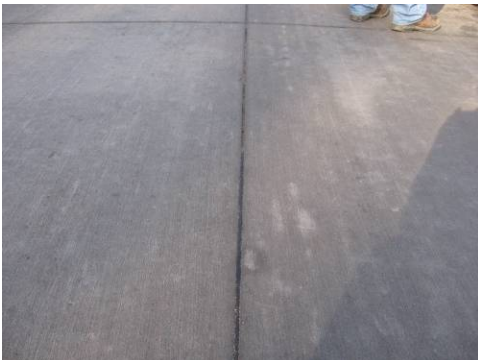
(c) Joint sealing damage of longitudinal joint at slab #2

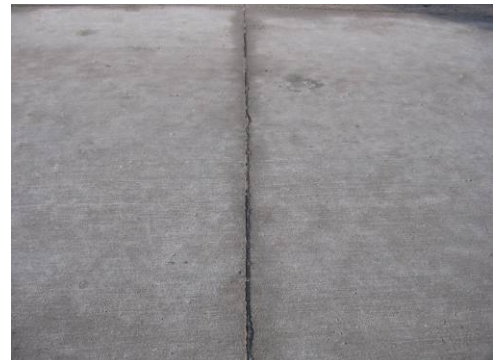
(d) Joint sealing damage of transverse joint at slab #2

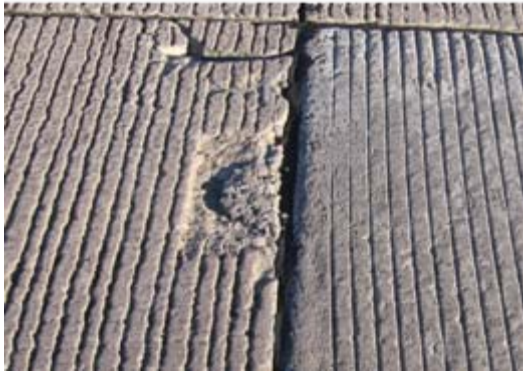
(d) Spalling of transverse joint at slab #18

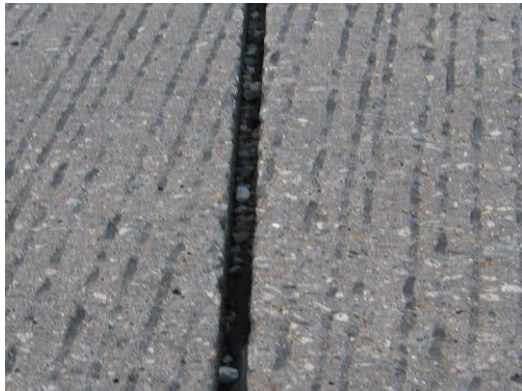
(a) Joint sealing damage of transverse joint at slab #1

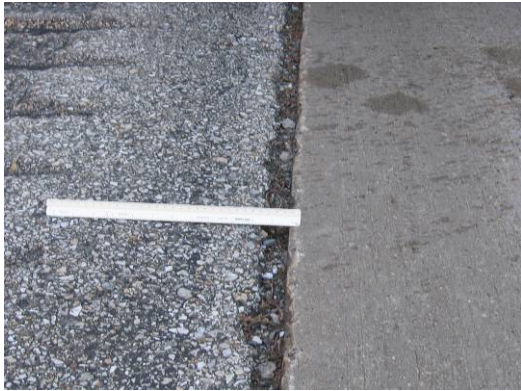
(b) Lane to shoulder separation at slab #5

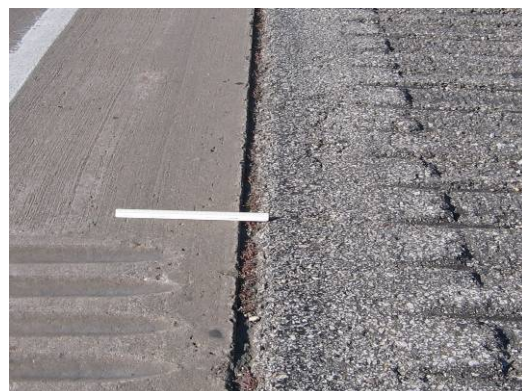
(c) Lane to shoulder separation at slab #17

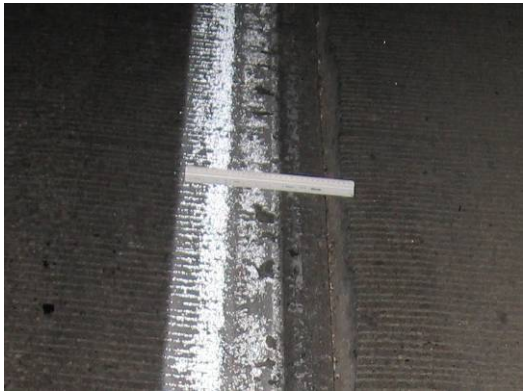
(d) Lane to shoulder separation at slab #9

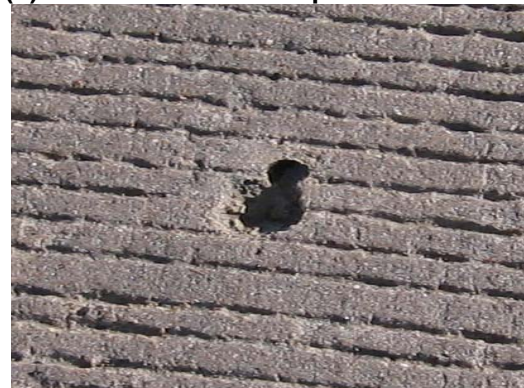
(c) Popout at slab #18
